File: DP000031 - Townhouse Development at 3494 Wishart Rd

DEVELOPMENT PERMIT DP000031

8. This Development Permit authorizes the construction of 50 townhomes along with any associated site works. The Lands shall not be altered, nor any buildings or structures constructed, except in accordance with the following conditions:

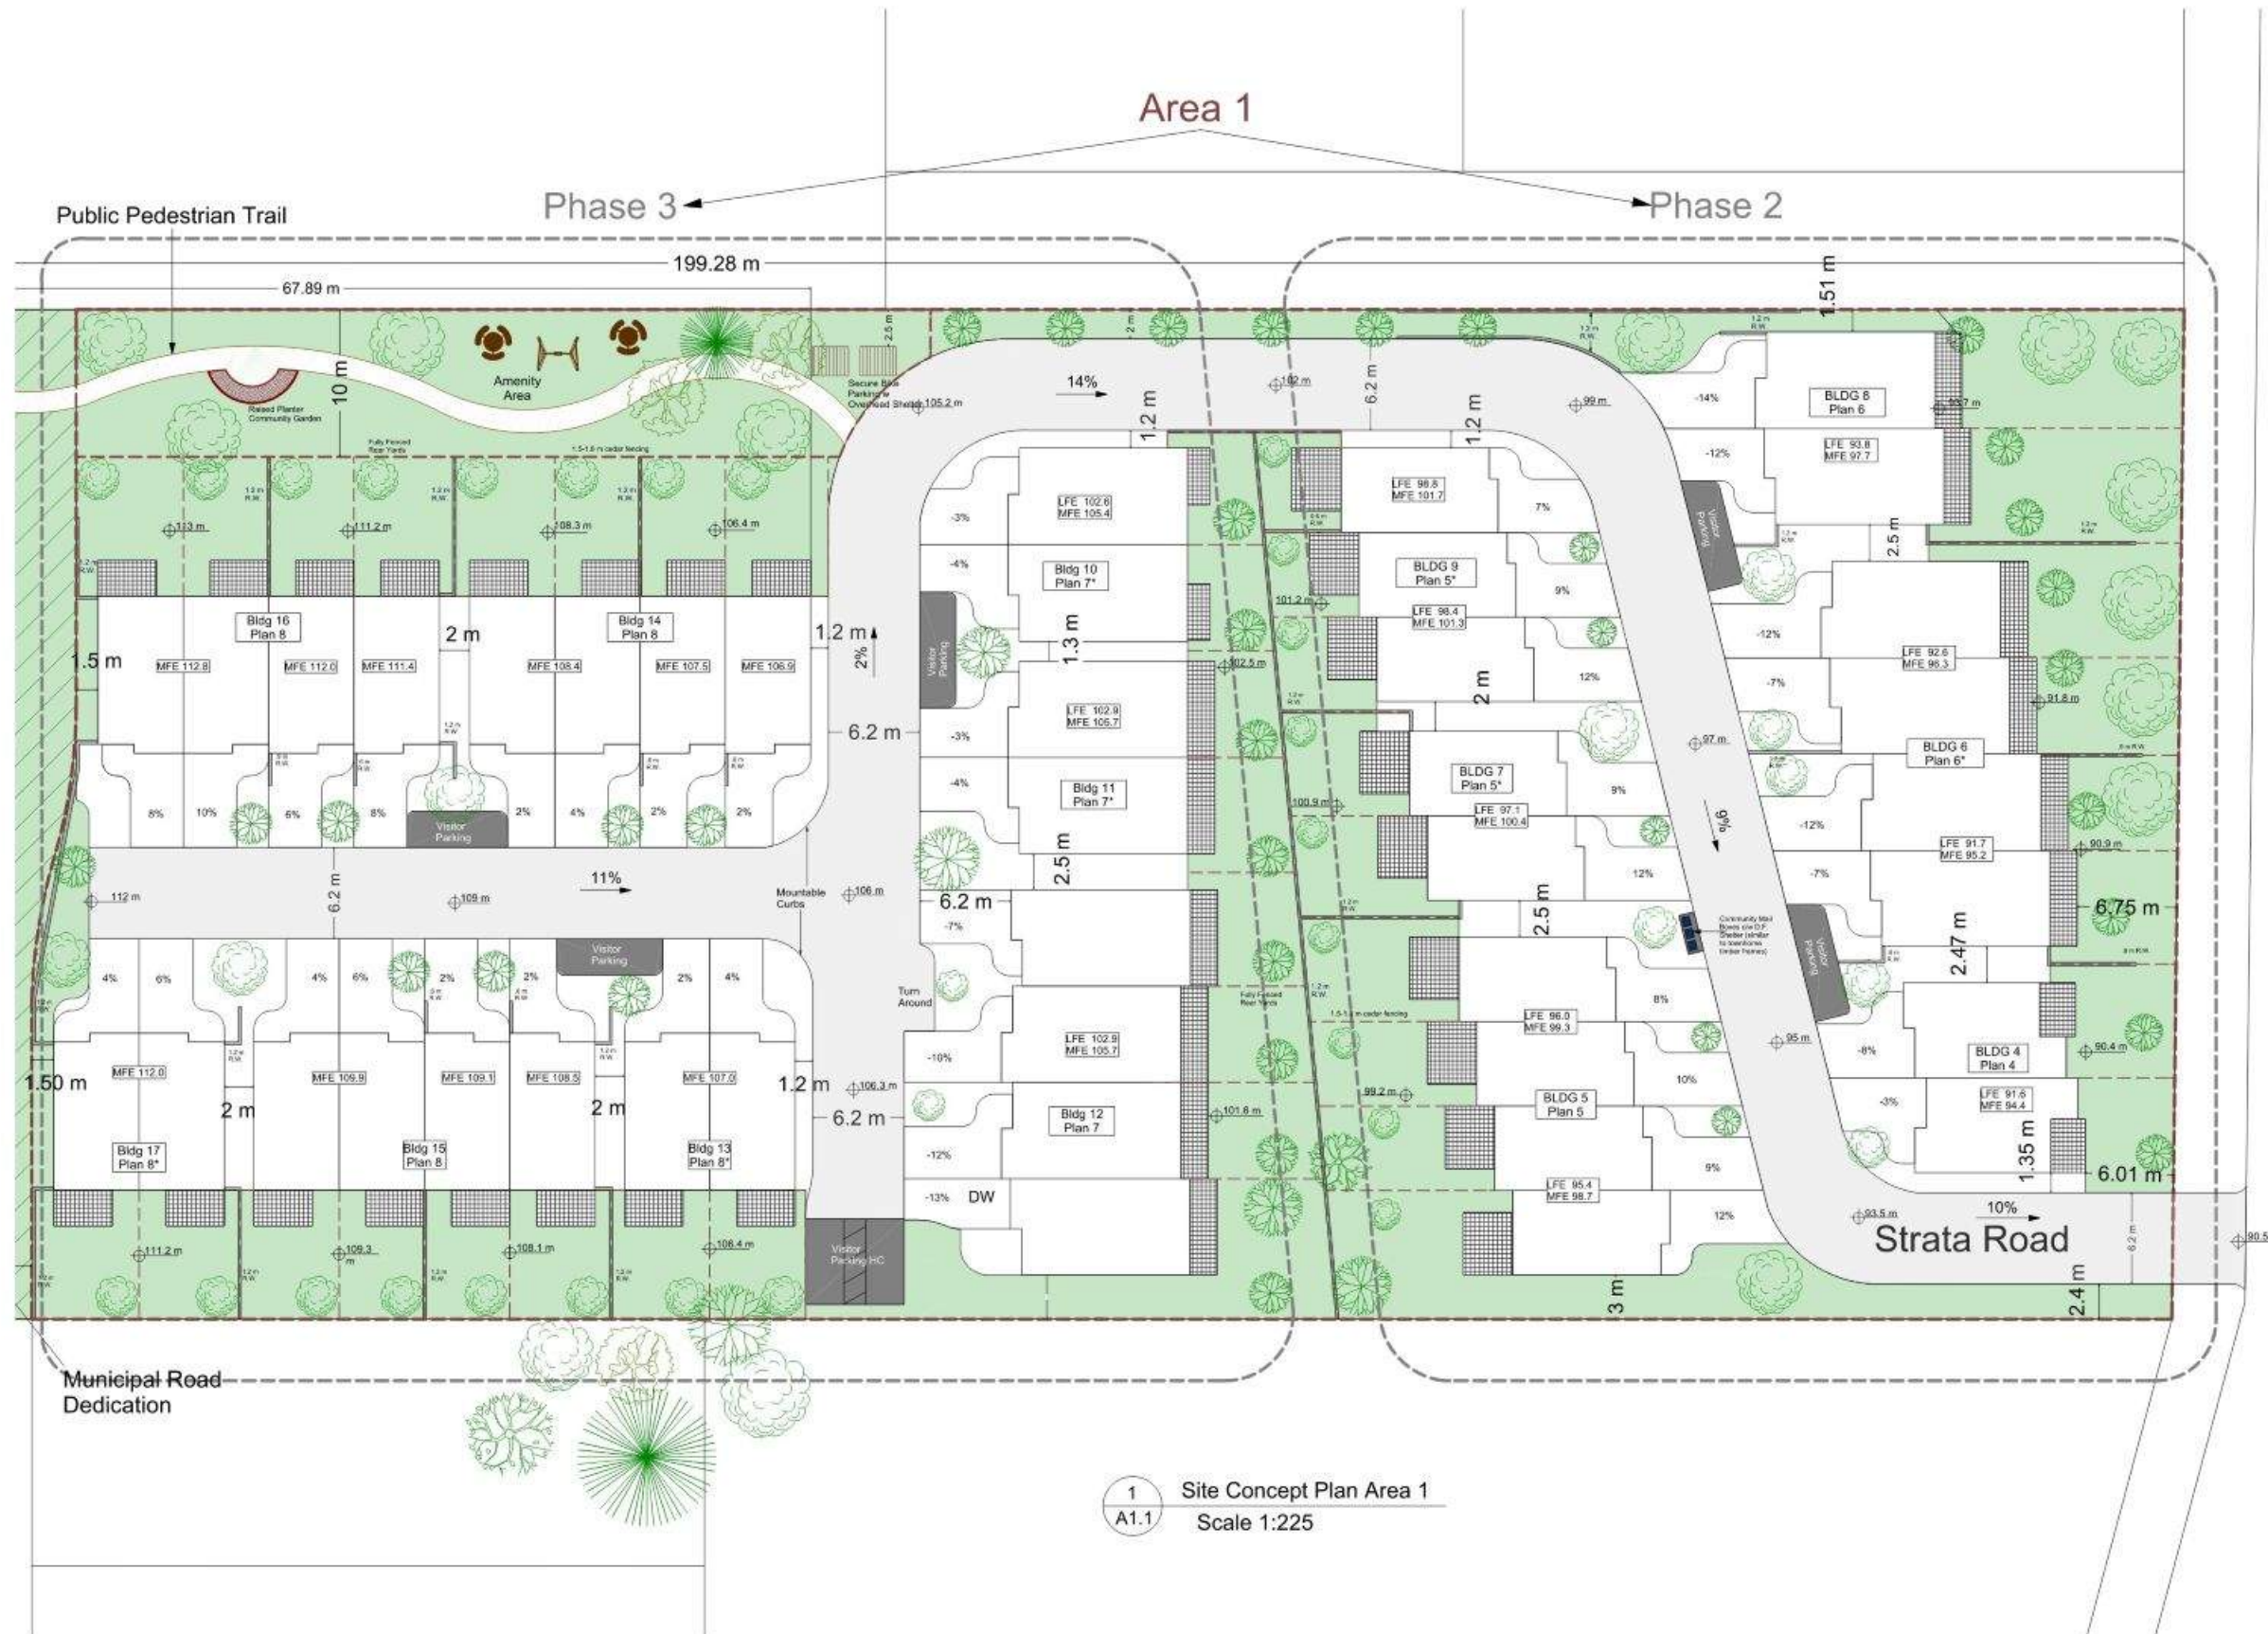
1 Site Concept Plan Area 1
A1.1 Scale 1:225

Site Plan - Strata Road (Phase 2 & 3)

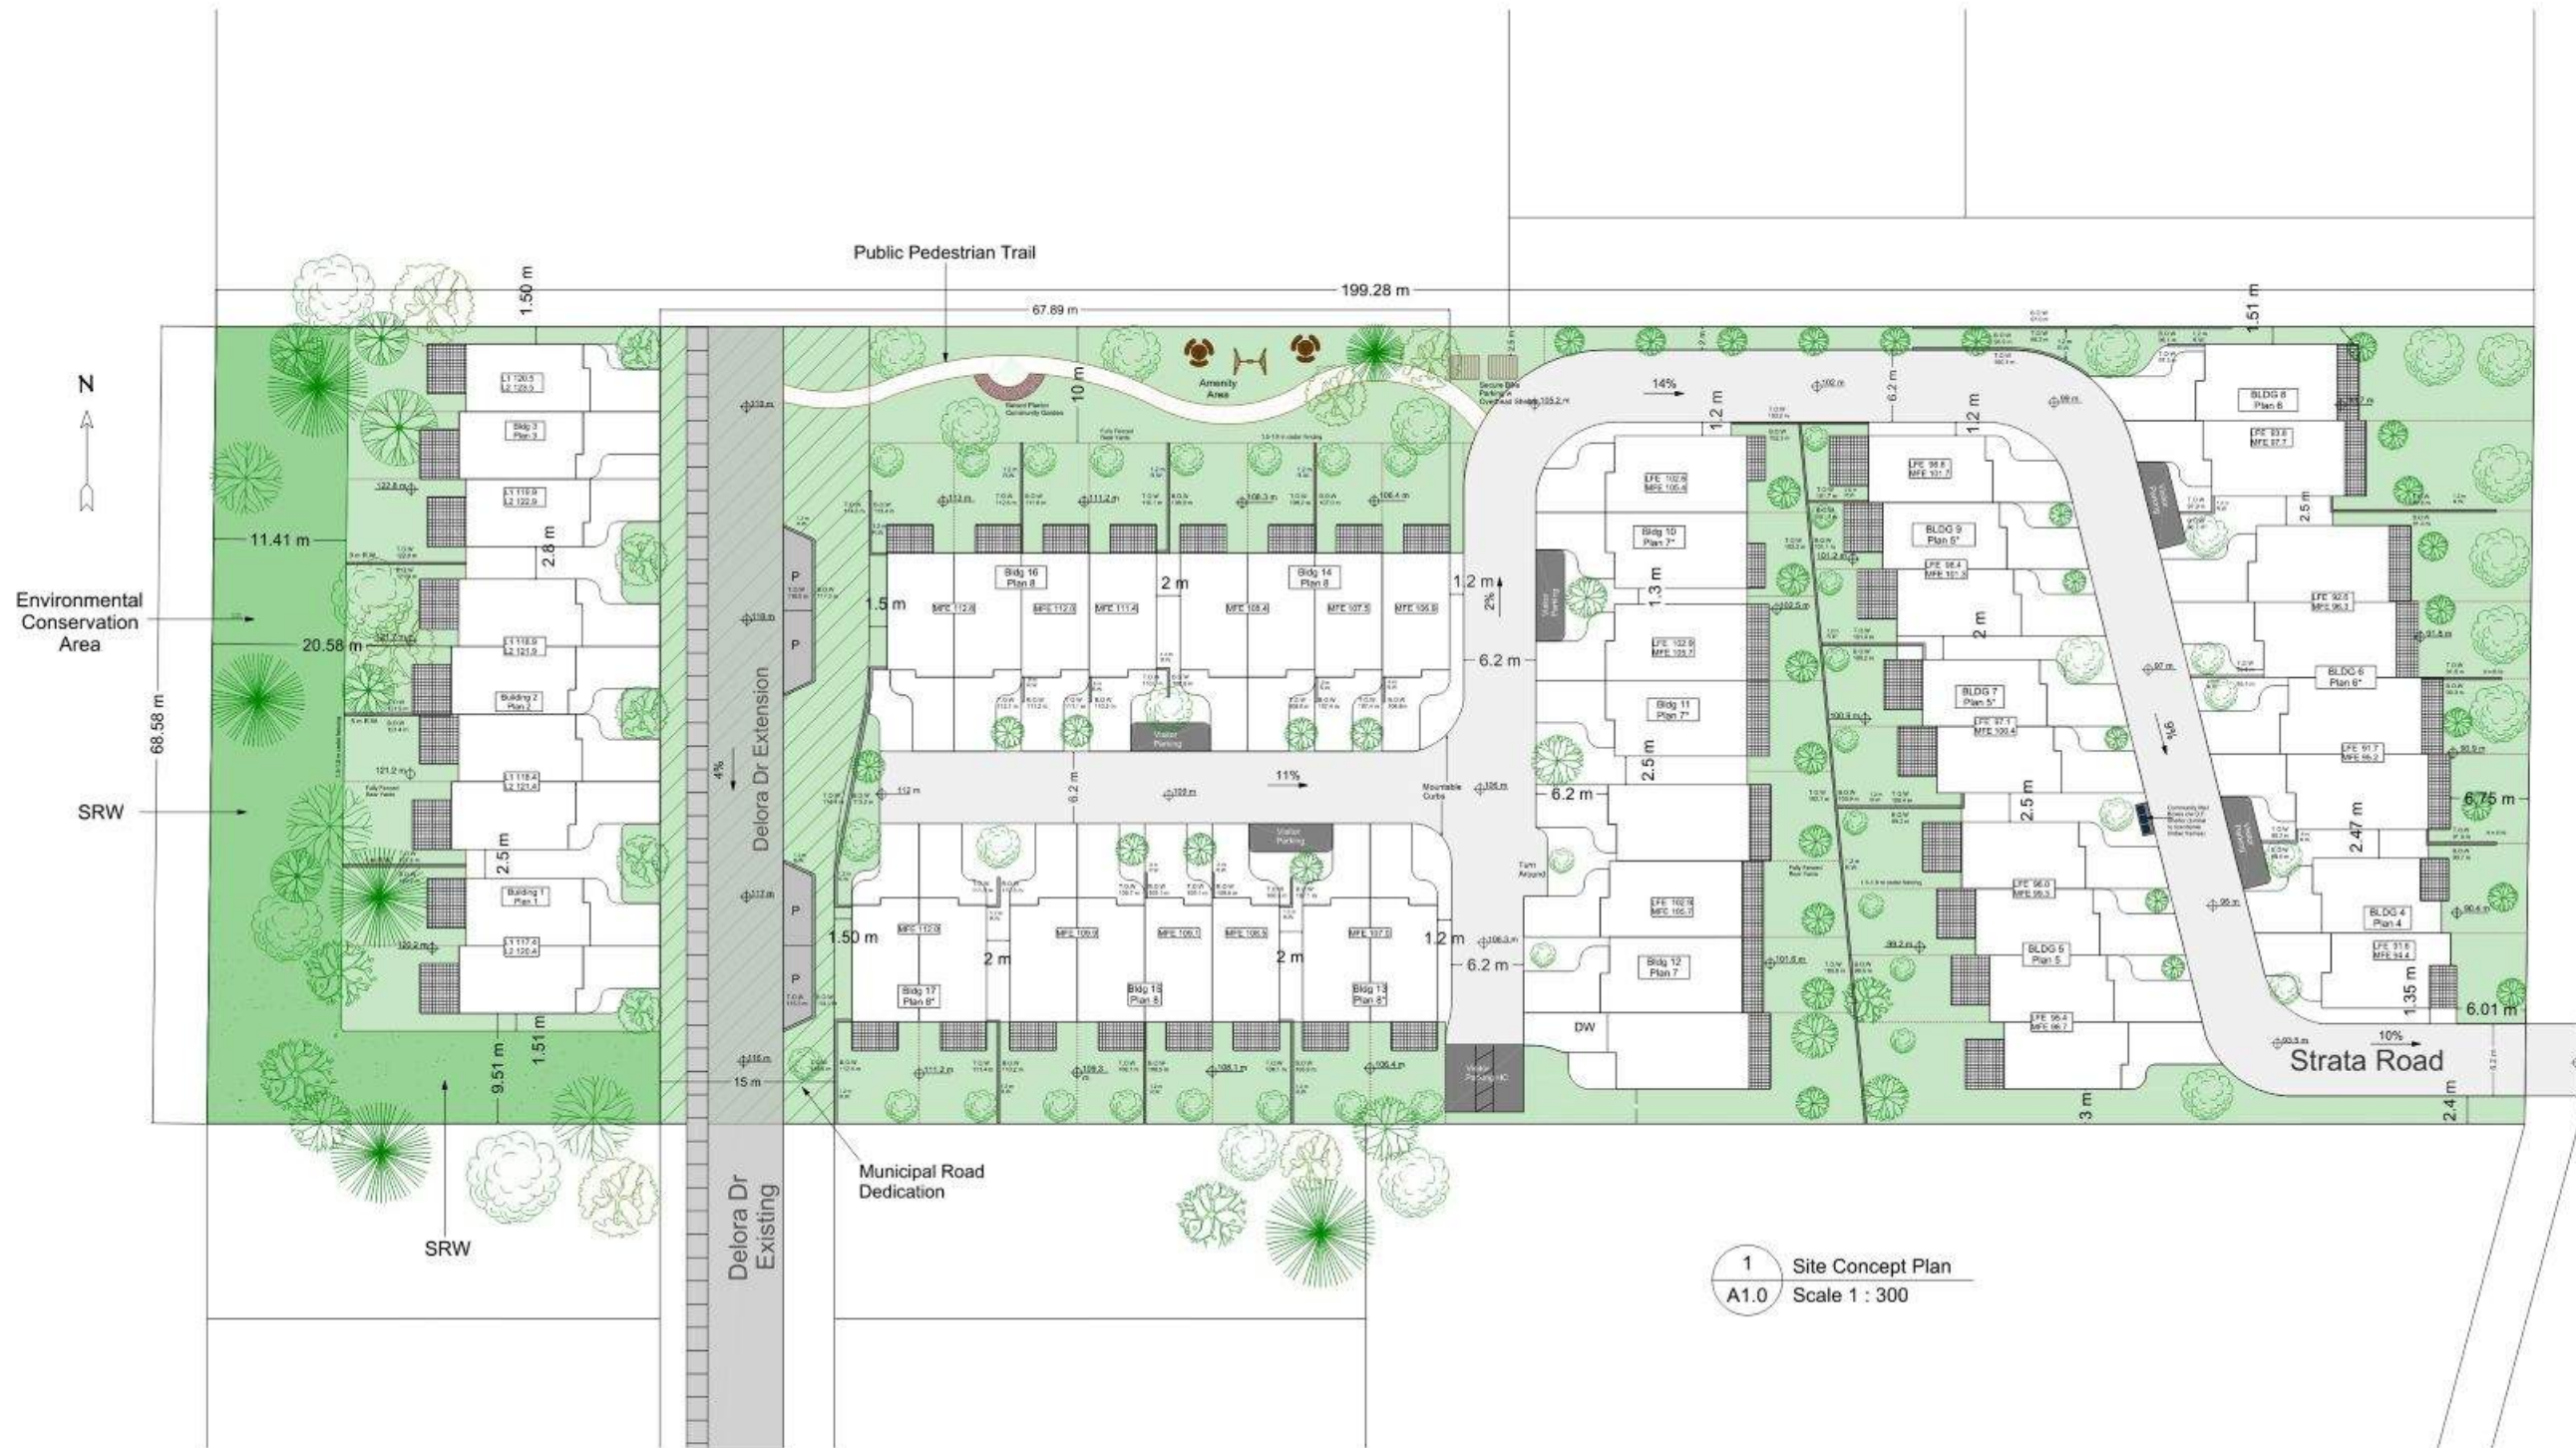
1 Site Concept Plan
A1.0 Scale 1 : 300

Site Plan - Retaining Wall Layout

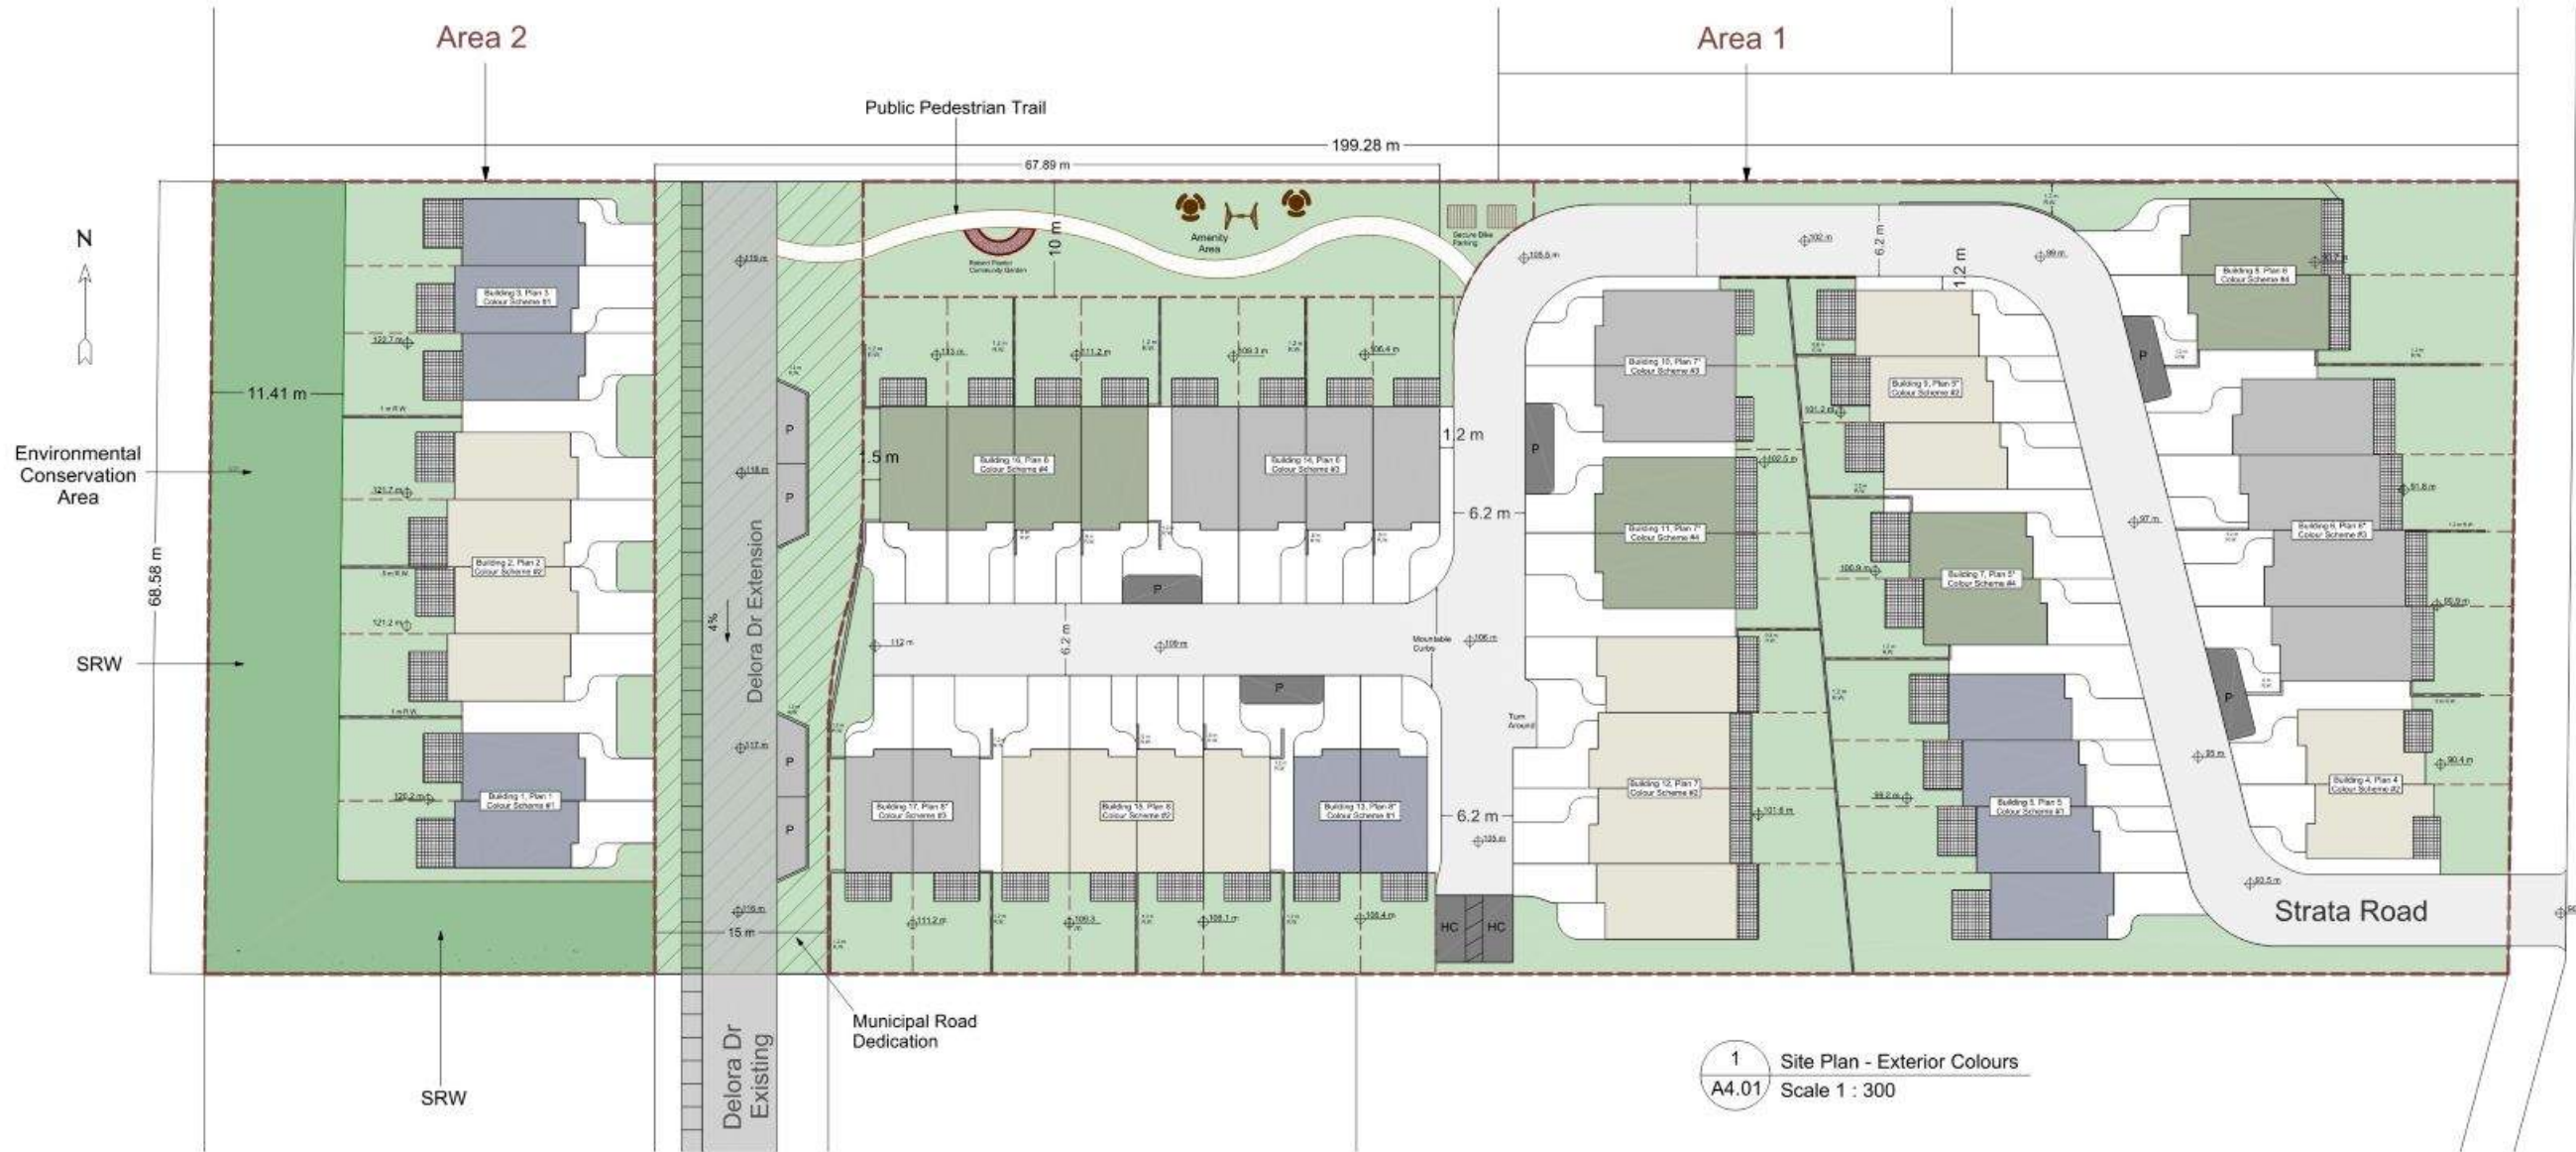
1 Site Plan - Exterior Colours
A4.01 Scale 1 : 300

Building Exterior Colour Scheme Layout

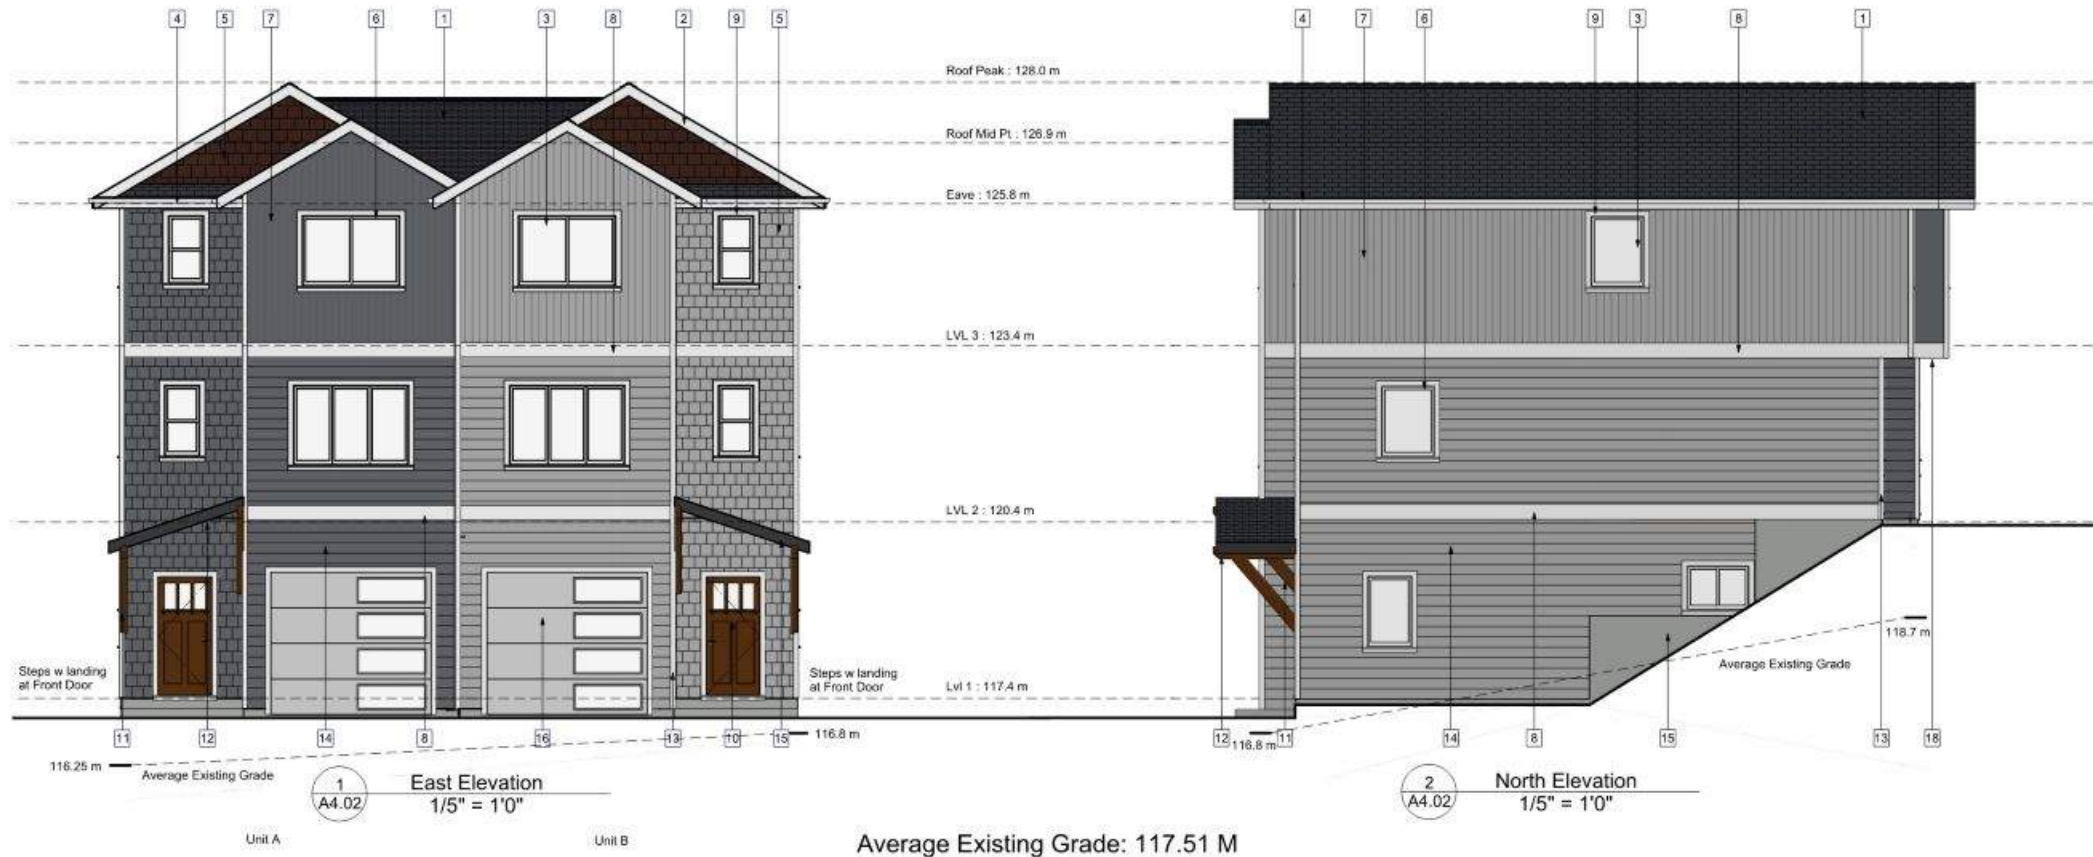
Building 1 (Plan 1) - Elevations

Average Existing Grade: 117.51 M
Building Height : 9.39 M

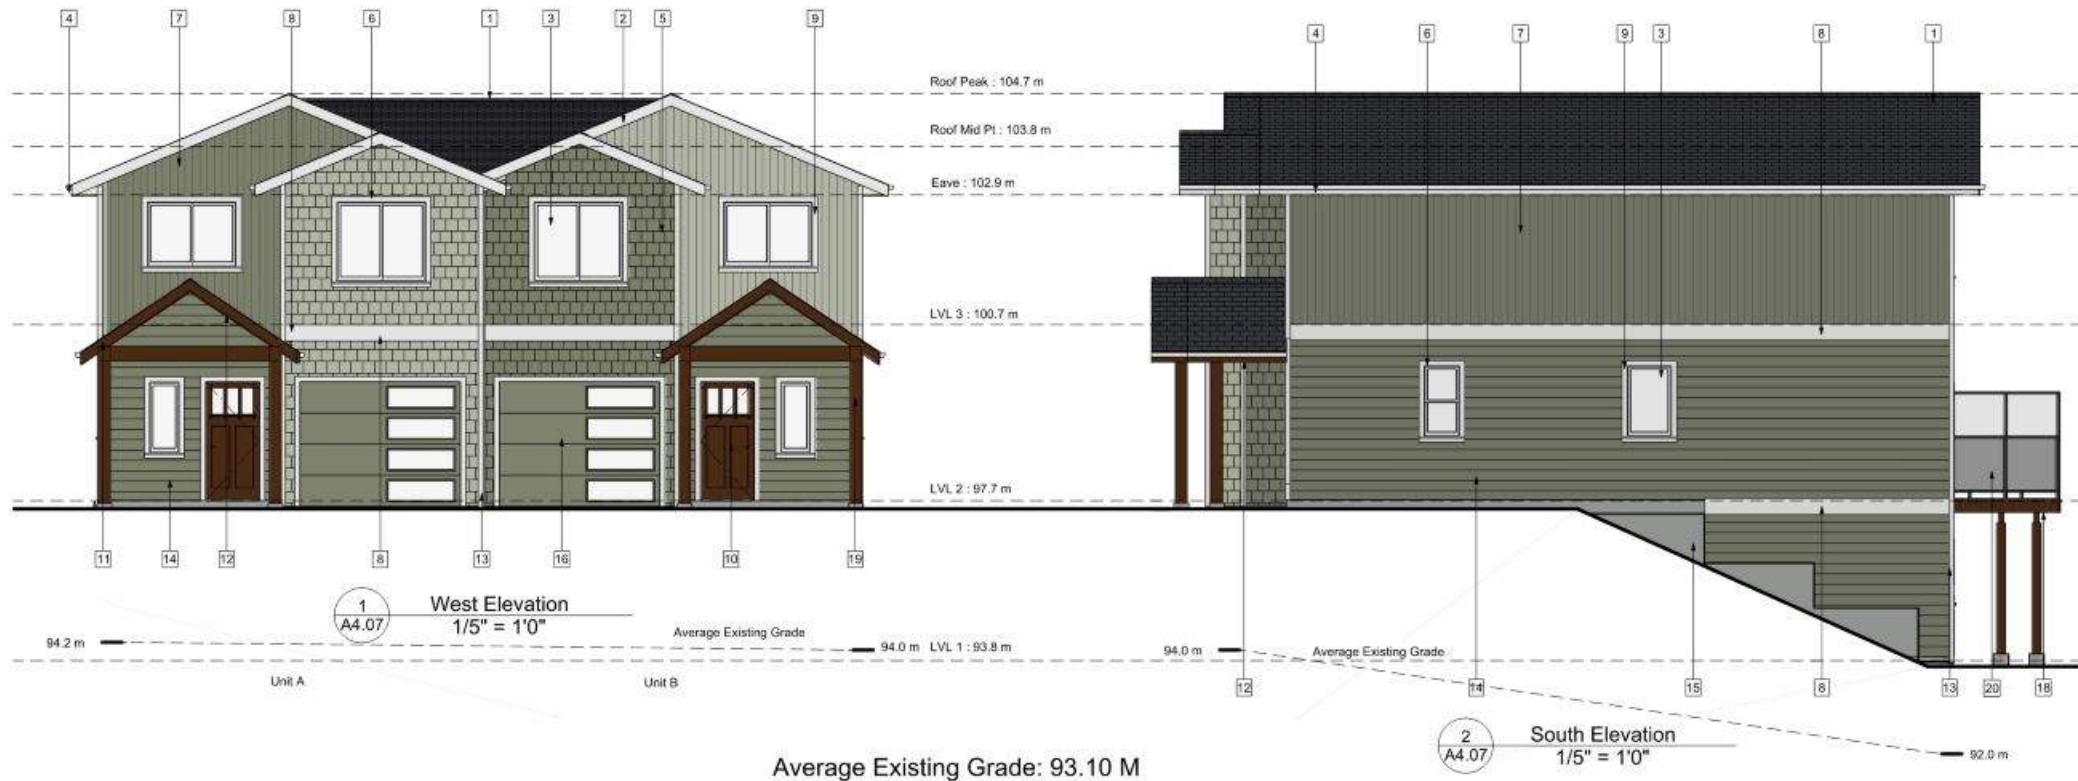
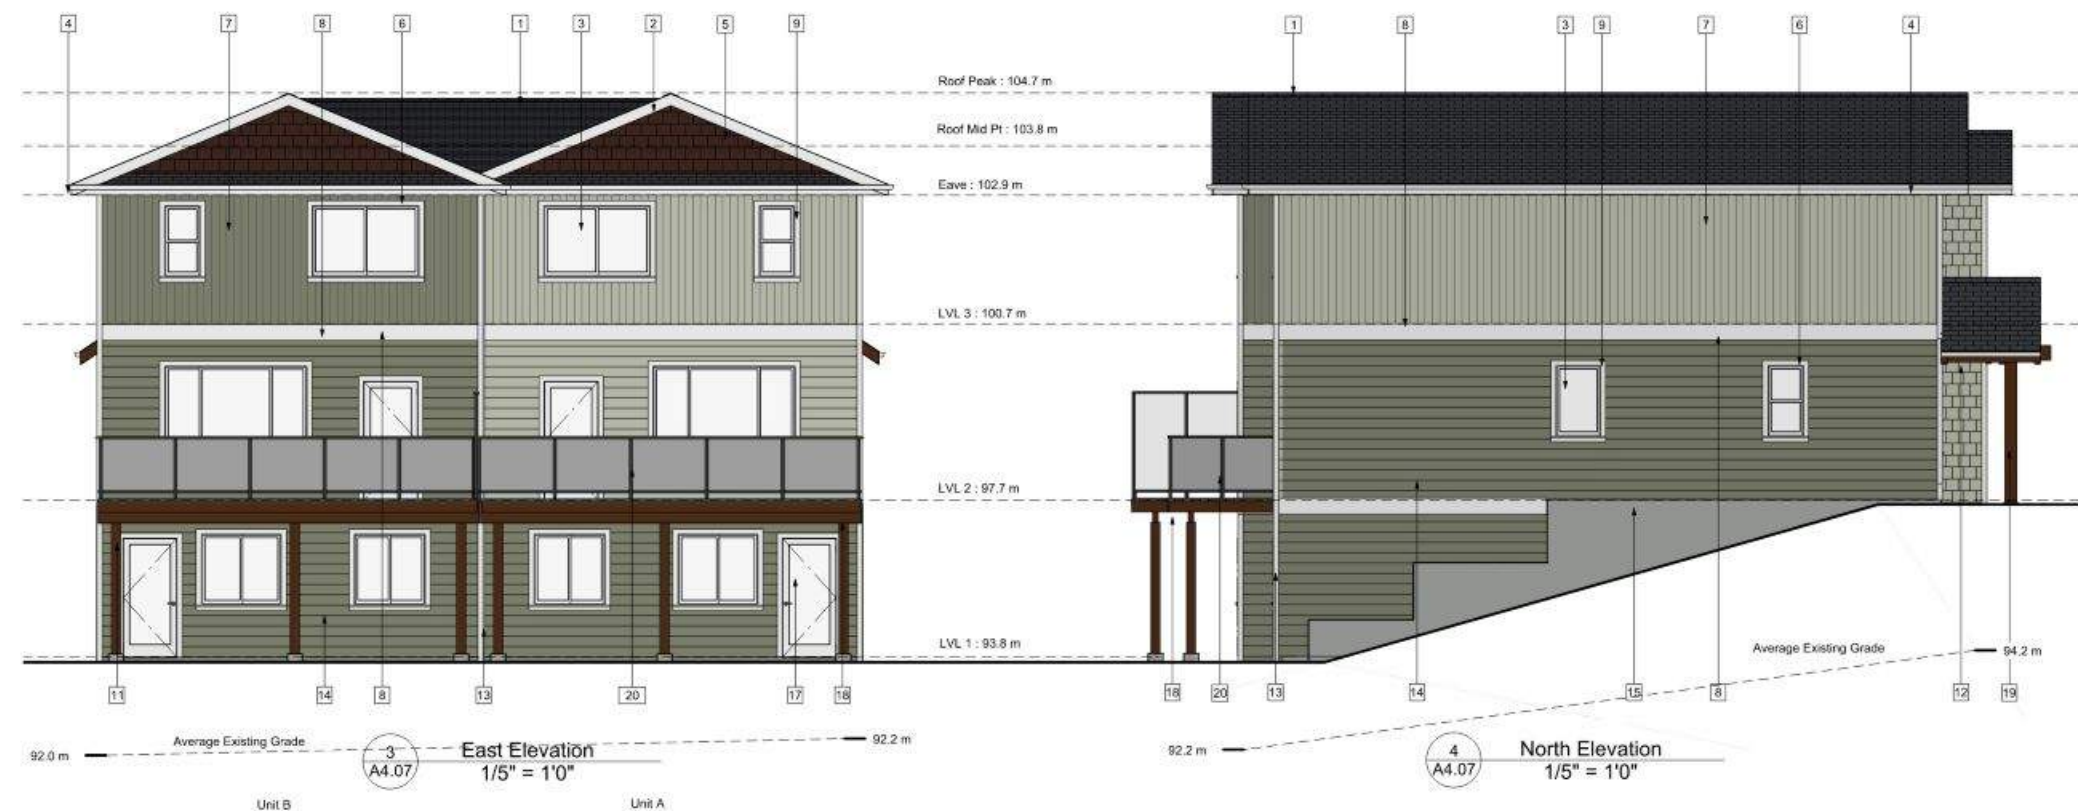
Building 8 (Plan 6) - Elevations

Average Existing Grade: 93.10 M
 Building Height : 10.70 M

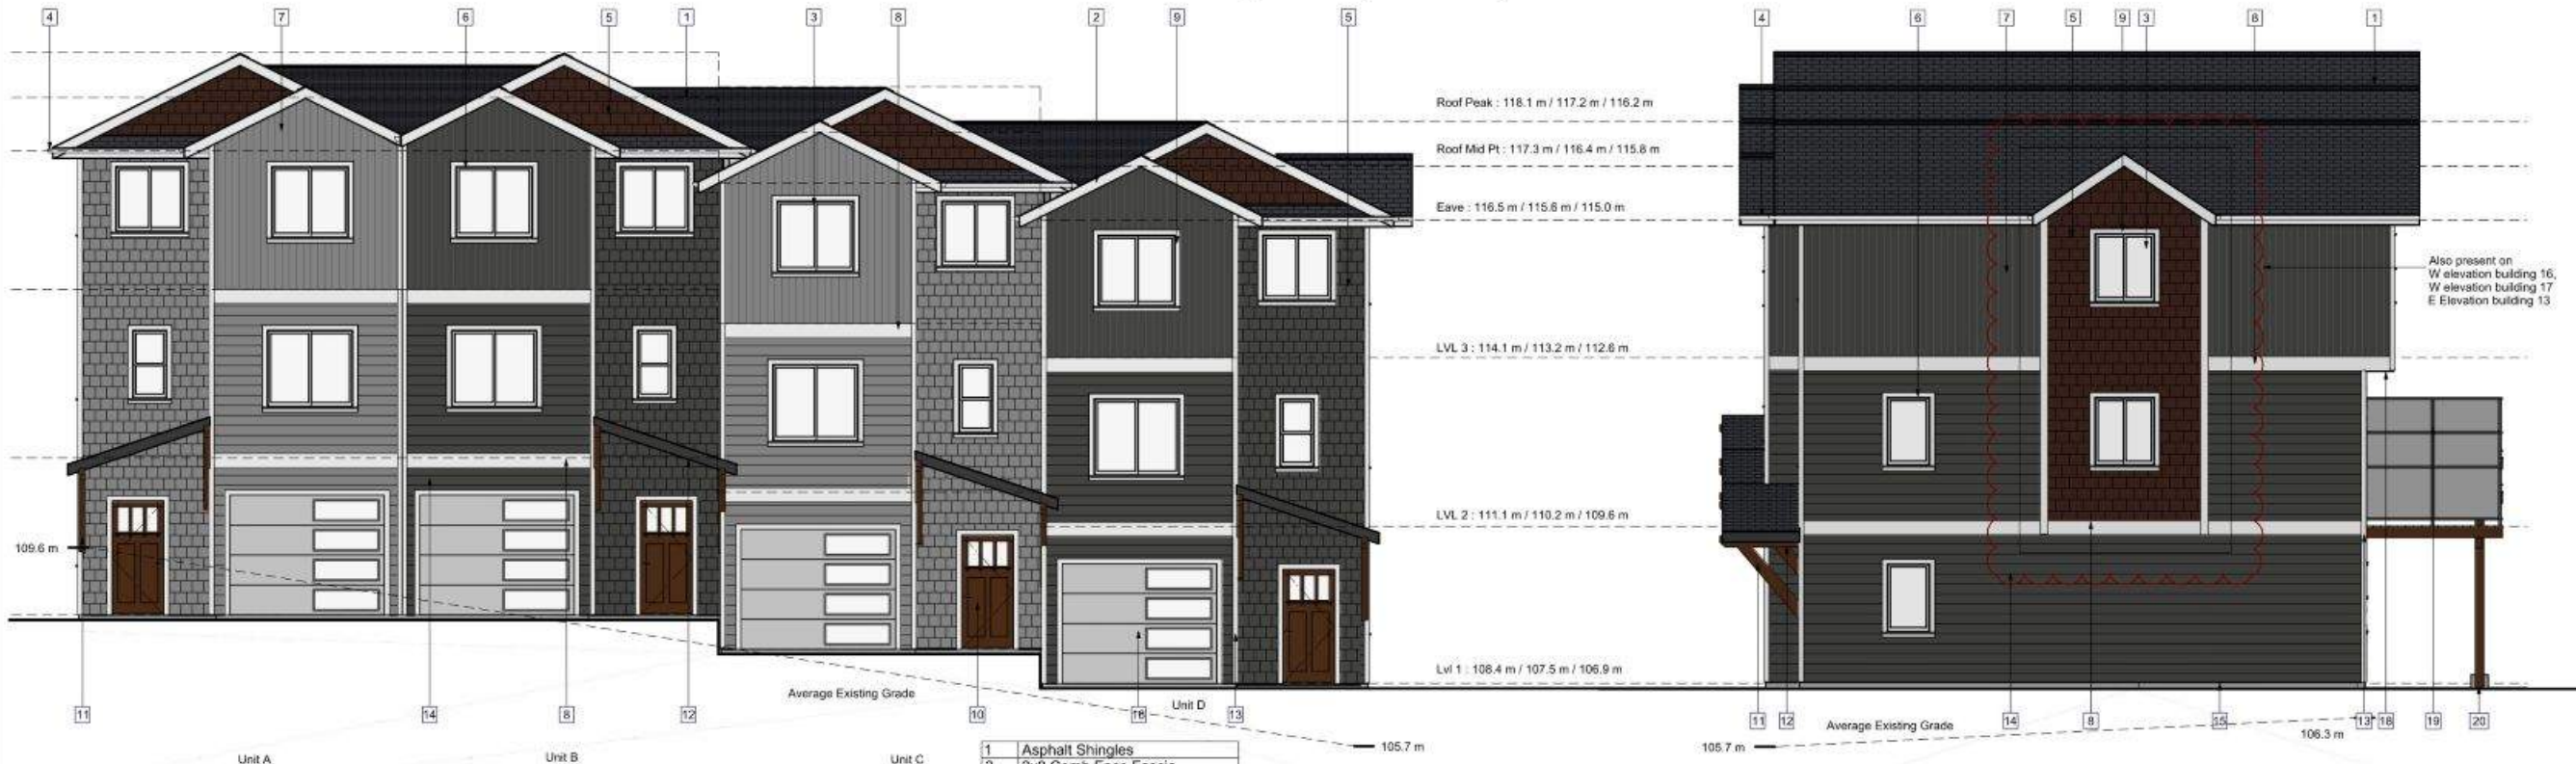
1 South Elevation
A4.09
1/5" = 1'0"

Building 14 (Plan 8) - Elevations
