DEVELOPMENT PERMIT DP-22-019

1. This Natural Hazards (Steeply Sloped), Environmental (Hillside), and Form & Character (Intensive Residential) Development Permit applies to those lands within the City of Colwood described below, and any and all buildings, structures, and other development thereon:

820 Bexhill Place

Figure #1 – Site Map – Proposed Lot Design & Tree Protection Fencing

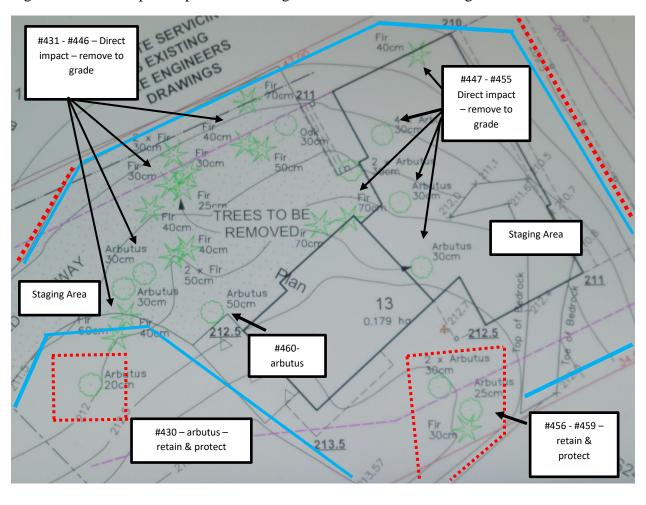
Tree Protection Fencing (TPF)
Staging Area

Materials storage will be confined to the proposed new road dedication and open areas
of the site. See Figure #1 – Site Map

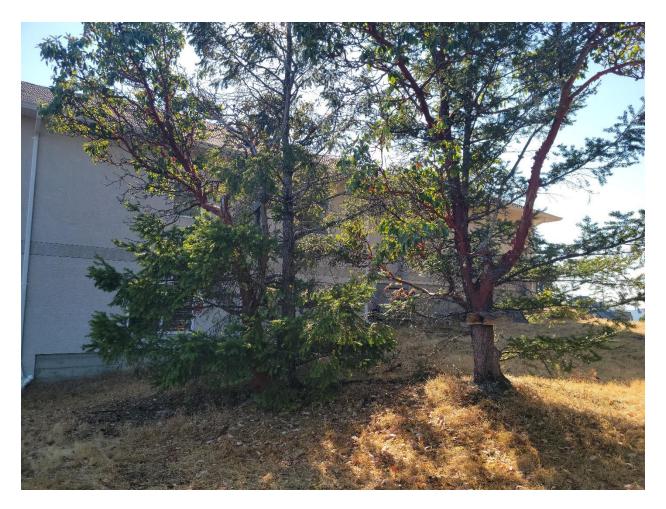
Photo #3 – Fir and Arbutus Trees - #456 - #459

Each of these trees have been identified for retention and protection under the existing proposal. Tree Protection fencing shall be required to be positioned approximately 1m out side the tree groupings drip-line.

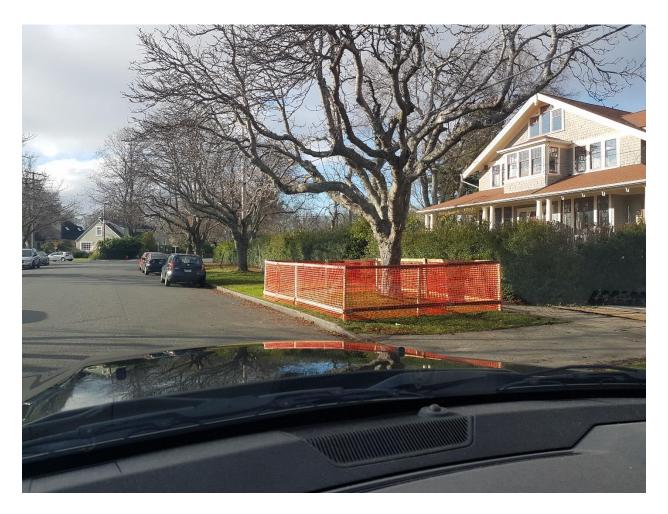
Photo #4 – Tree Protection Fencing

In this photo you can see an example of an acceptable tree protection fencing barrier. The Municipal Boulevard must be protected to reduce soil and root compaction. The TPF fence shall have a posted sign reading "Tree Protection Area - No Admittance".
