File: DPA00004 - Grading Works at Lot I & Lot J Beachlands

DEVELOPMENT PERMIT AMENDMENT DPA00004

Arborist Report for Development Purposes
Re: Proposed Development, and Construction

**APPENDIX B –
AUGUST 2023 - ON POINT PROJECT ENGINEERS ‘BEACHLANDS –
GEOTECHNICAL SECTIONS’**

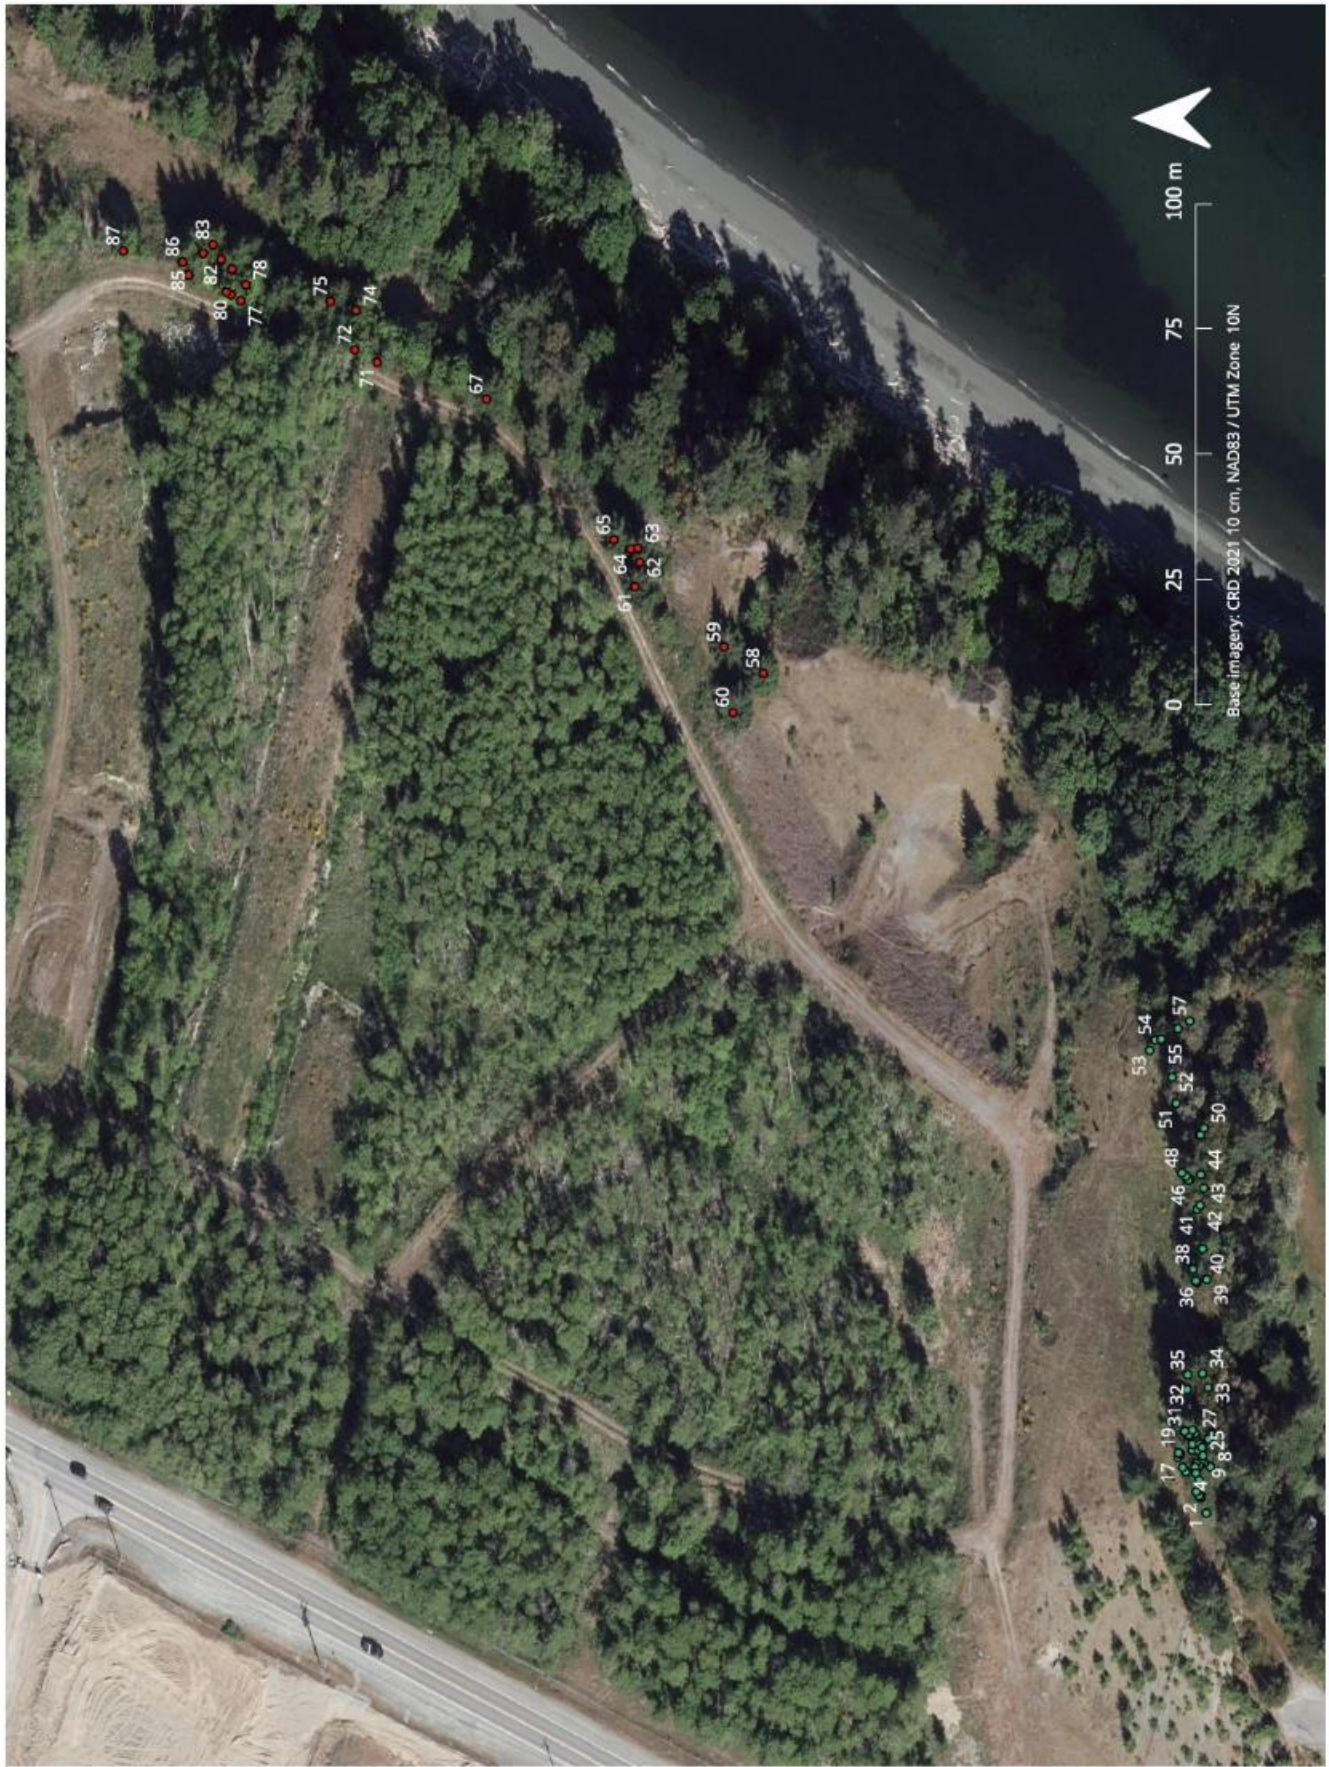
Beachlands Bluffs Tree Inventory - August 29, 2023 - Coordinates Provided by On Point Project Engineers Ltd.

- Retain Tree
- Remove Tree

Figure 1 – Aerial view of property and tree locations (March 26, 2024)

During our site work on August 3rd and 4th, 2023, a total of (87) trees were initially inventoried in 2 areas of the lot (Figure 1). Only trees that are of a Protected size under City of Colwood's Urban Forest Bylaw No. 1735, 2018 were inventoried. Several multi-stemmed trees that were tagged during our site visit were not reflected in the final inventory as they were later determined to be undersized based on Colwood's multiple stem diameter formula. A third area of the lot (Figure 3) was surveyed by myself (Ryan Senechal) and Miche Hachey on January 31st, 2024 to determine if additional Bylaw Protected trees were within the grading footprint. No additional trees were identified as being in direct conflict. Grading may encroach on eastern bluff trees, and measures have been outlined in 6.0 and 7.0 of this report to address those potential disturbances.

- An aerial site map was generated indicating tree locations (Figure 1).
- A visual inspection of (76) protected trees and (11) unprotected trees was completed. An additional area was surveyed on January 31st, 2024 (Figure 3) to determine if Bylaw Protected trees were in that area.

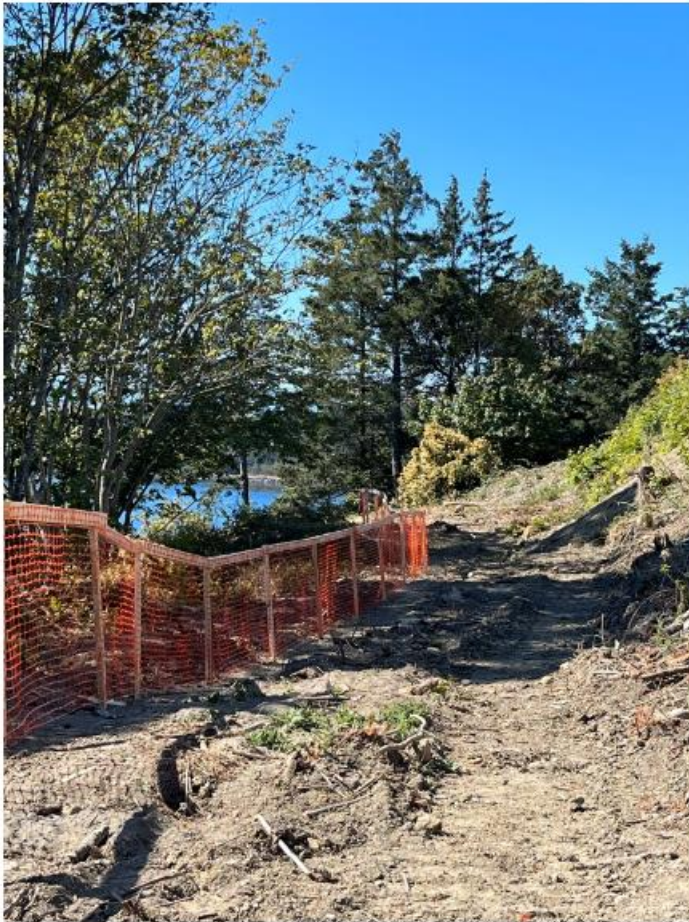
Figure 3 – Wood frame tree protection fencing at the edge of the eastern bluff

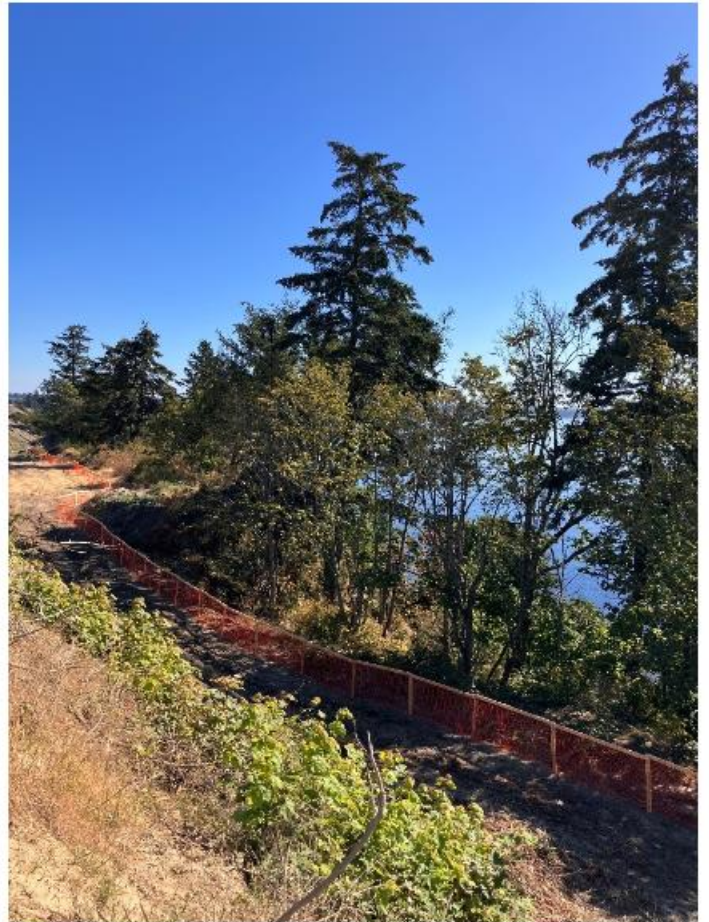
Figure 4 – Wood frame tree protection fencing at the edge of the eastern bluff

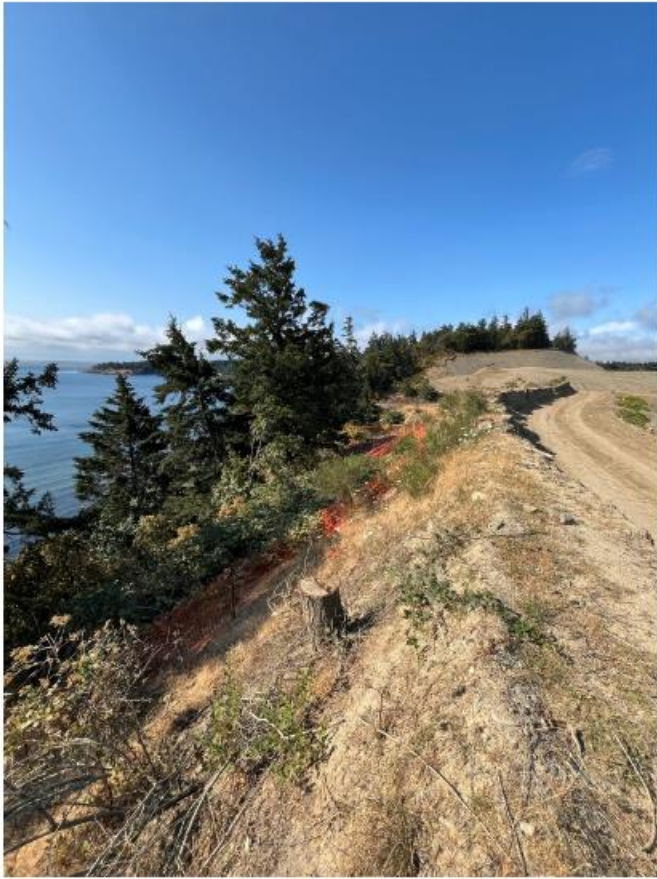
Figure 5 – Stumps remaining to be removed with arborist supervision

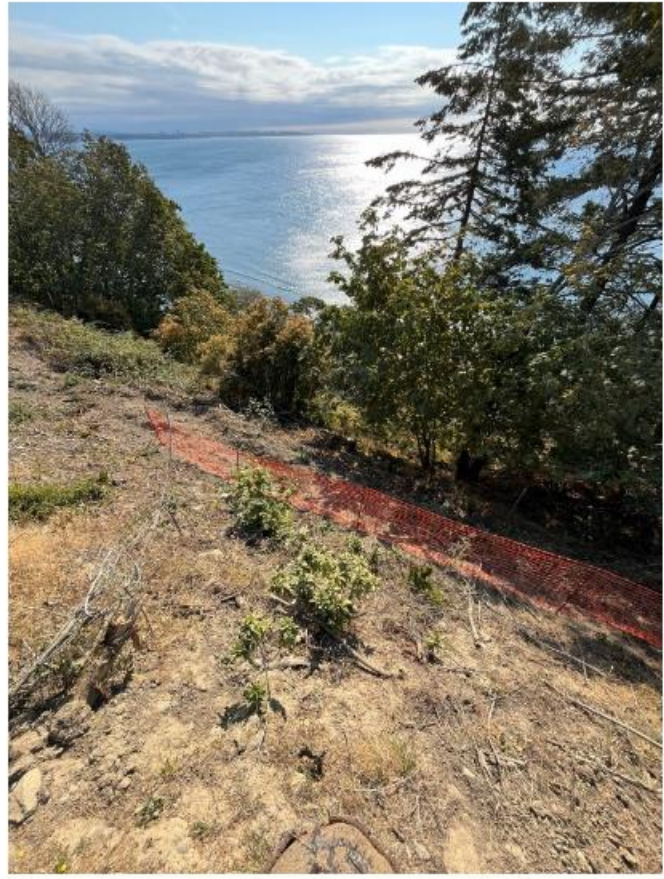
Figure 6 – T-post and mesh tree protection fencing on steep slopes above the eastern bluff

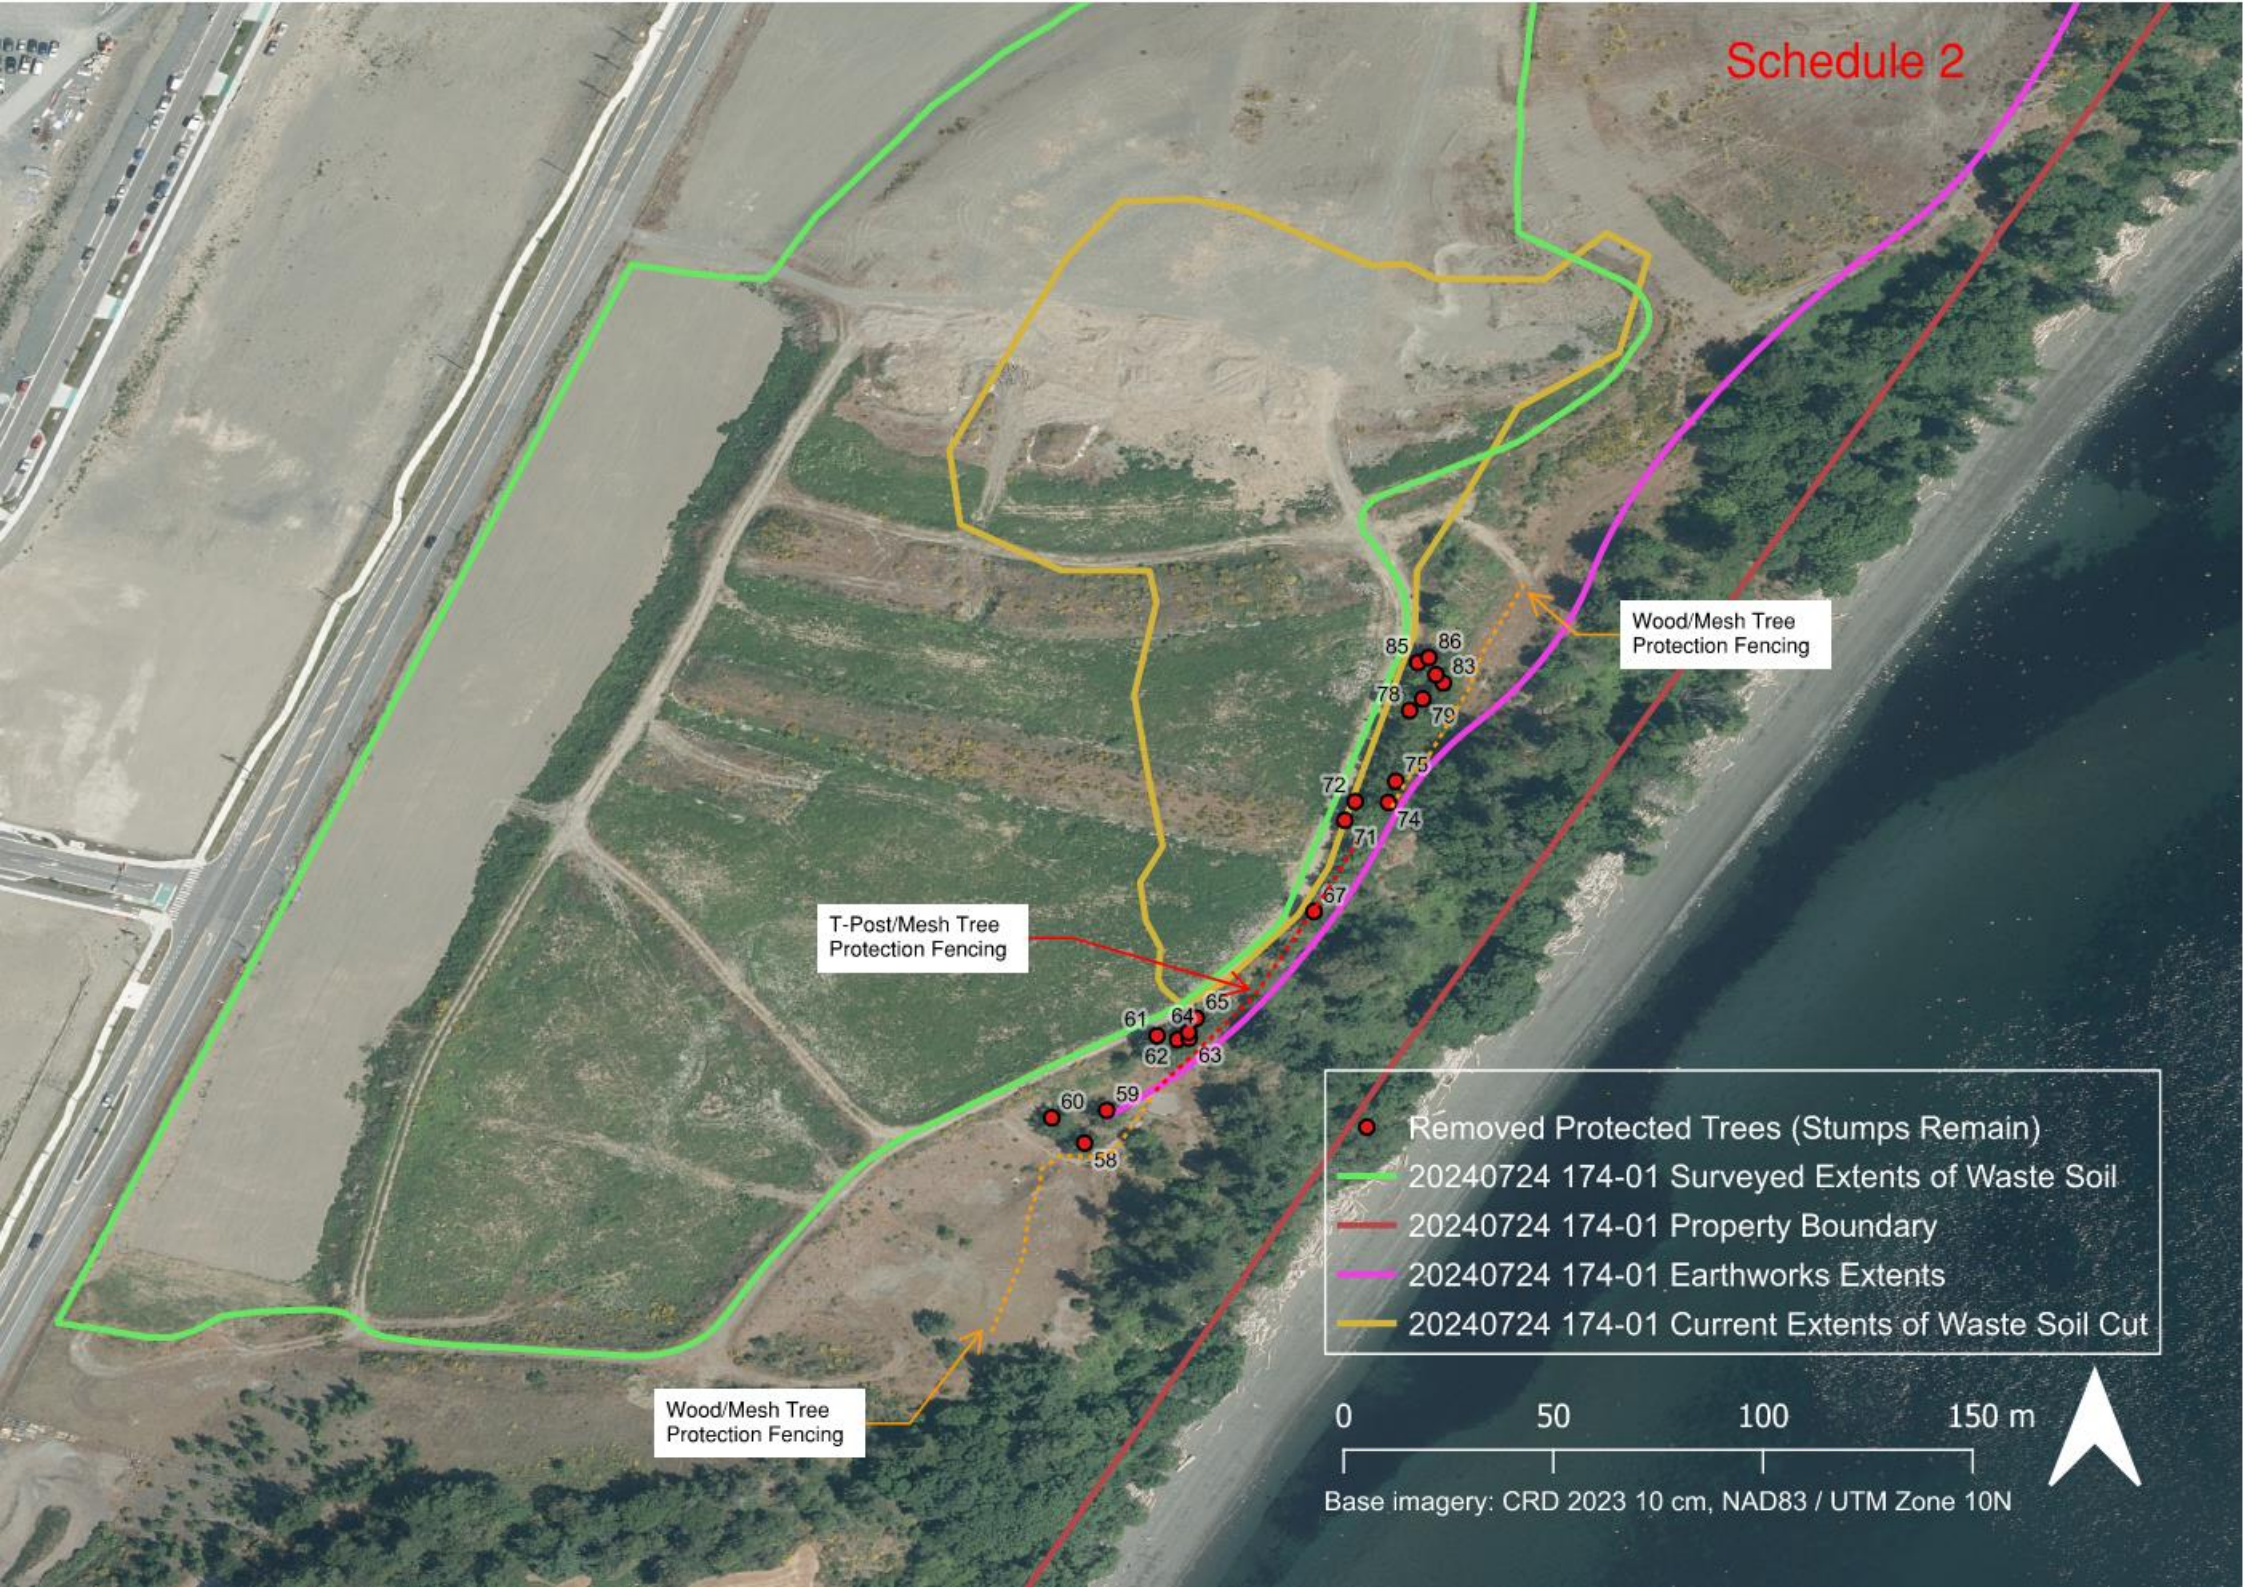
Schedule 2

T-Post/Mesh Tree Protection Fencing

Wood/Mesh Tree Protection Fencing

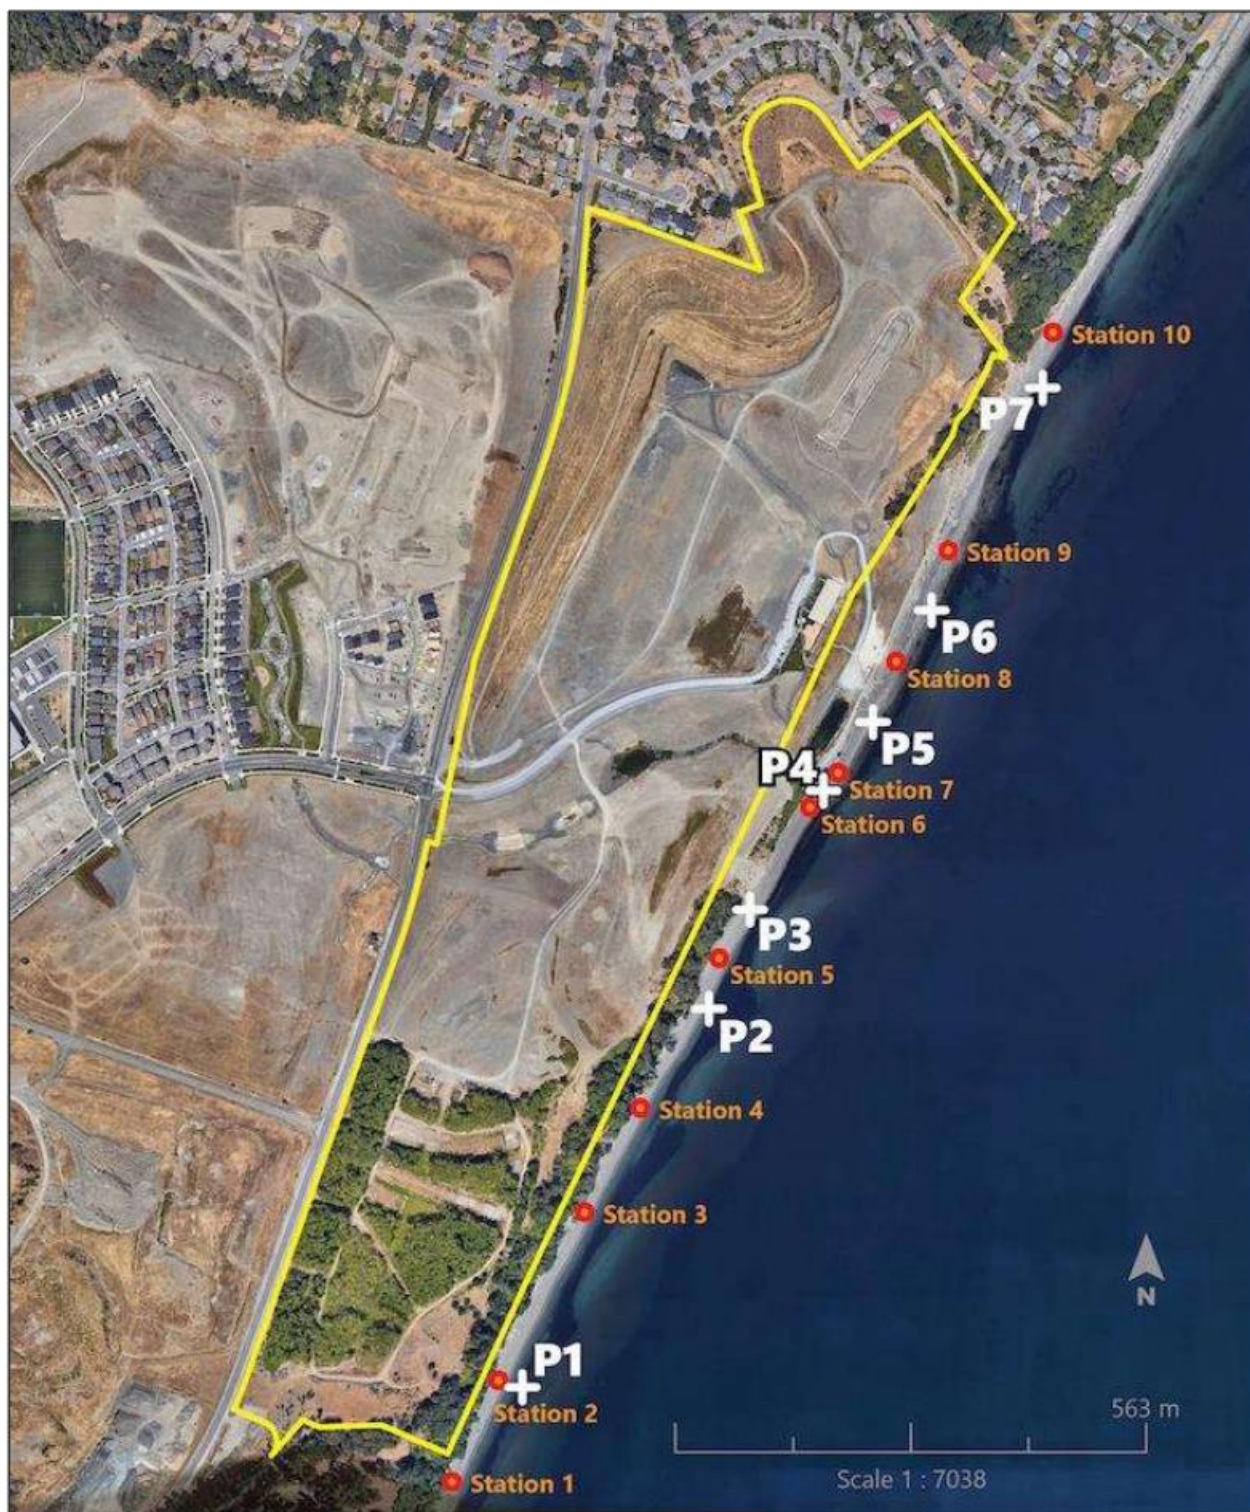
Figure 1 – Aerial view of site showing property line, reference stations, and photograph locations (Google Earth)

The figure also shows the locations of various stations (red circles) and photograph locations (white plus signs) that are referred to in this memorandum. The ten stations correspond to locations at which NHC (Ref. 12) provided initial estimates of bluff toe recession; and the seven photograph locations are those from which photographs provided in this memorandum were taken.

Figure 1 provides an aerial view of the intended location of the Royal Beach Development and its vicinity, including the adjacent shoreline. The figure includes an identification of the property boundary of the development (yellow line). As apparent in the figure, most of the development will occupy a former mining site (shown as barren land in the figure). Mining activities at this site ceased in 2007.

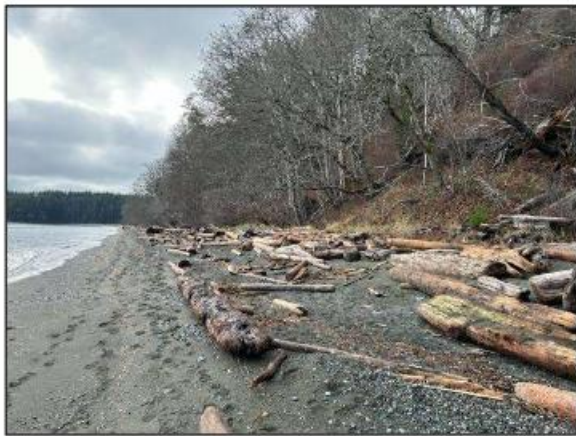
Figure 2 - View of shoreline at location P1

Westmar undertook a site visit on January 16, 2023, to assess the shoreline and the bluffs. Figure 2 to Figure 7 show general views of the shoreline and bluffs at locations along the shoreline, progressing from the south-southwest towards the north-northeast (subsequently referred to as progressing from the south to the north). At the time of the visit, the tide level was approximately 1.2 m below HHWLT (higher high water large tide). Figure 2 shows the shoreline and bluff at location P1 (see Figure 1), typical of the forested bluff along the southern portion of the shoreline. The bluff reaches an elevation of about 40 m GD in this vicinity. In this memorandum, GD denotes Geodetic Datum, which corresponds to the datum CGVD2013. Figure 3, taken at location P2, shows a similar view of the bluffs further along the shoreline where the bluff height is somewhat lower, and Figure 4, taken at location P4, shows the bluffs further to the north, as the forested slope transitions to an exposed bluff with height decreasing towards the north. Moving further north, Figure 5 and Figure 6 show views of the shoreline in this vicinity of Stations 6 to 8, where the backshore¹ includes a very low, steep bluff (about 2 m in height) above which the land slopes gradually up to an elevation of about 10 m GD. With respect to this area, Figure 5 shows riprap placement at location P5, while Figure 6 shows an exposed backshore at location P6. Finally, Figure 7 shows the bluff at the northern portion of the property. (Observations of the erosion potential of the toe of the bluffs along the shoreline are provided in Section 7.2.)

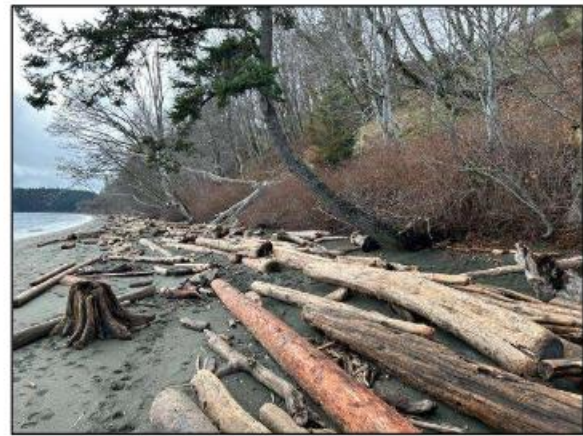
Figure 3 - View of shoreline at location P2

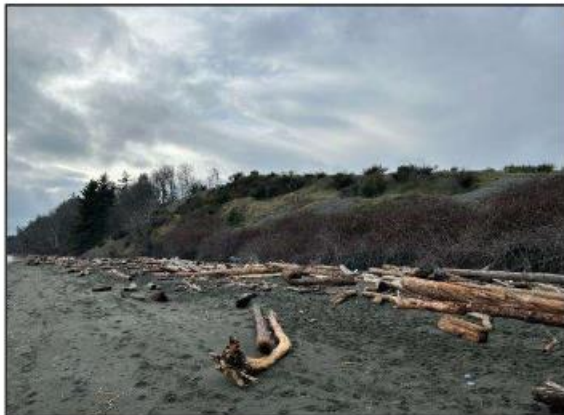
Figure 4 - View of shoreline at location P4

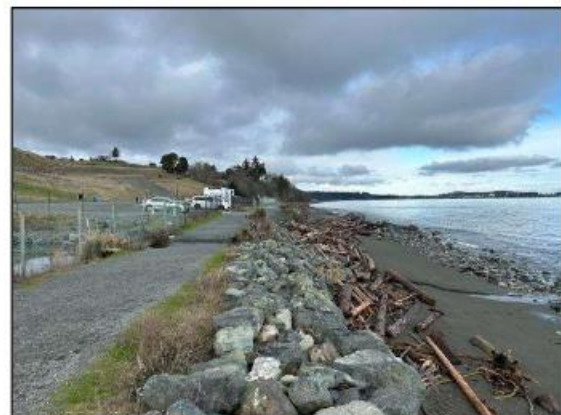
Figure 5 - View of shoreline at location P5

Figure 8 to Figure 11 show views of the base of the bluffs at four locations, while Figure 5 and Figure 6 show views of the low-lying portion of the shoreline near Stations 6 to 8. Considering these in progression from south to north, Figure 8 shows a view of a near-vertical bluff base at location P1, exhibiting an exposed portion of the bluff base susceptible to future erosion, Figure 9 shows the bluff base at location P2 where the bluff slopes directly to the beach, and Figure 10 shows the bluff at location P3 (just past the northern end of the forested portion of the bluffs), showing erodible materials sloping down to the beach. Figure 5 and Figure 6, taken at locations P5 and P6 respectively, show the portion of the shoreline with a very low, steep bluff above which the land slopes upwards more gradually. In particular, Figure 5 shows riprap placement at location P5, while Figure 6 shows an exposed backshore at location P6. Finally, Figure 11 shows the base of the bluff near the northern end of the property, indicating a more gradually sloping bluff near the backshore, with erodible materials sloping directly to the beach.

Different mitigative measures may be adopted for different portions of the shoreline. For the low-lying portion of the shoreline near Stations 6 to 8, currently riprap protection is provided at the south end of this portion (Figure 5), there is no such protection at the north end of this section (Figure 6), and there is degraded riprap in between (not shown). Given the current, degraded state of this portion of the shoreline, and the likelihood of significant pedestrian traffic accessing the beach here in the future, it is anticipated that the degraded / partial shoreline protection in this area may be replaced by an aesthetic shore protection scheme, for example, entailing smooth, rounded rocks with vegetative cover, with suitable pedestrian access to the beach, and that there will be landscaping improvements to the land above the backshore. These steps will eliminate or significantly limit erosion potential in this area.

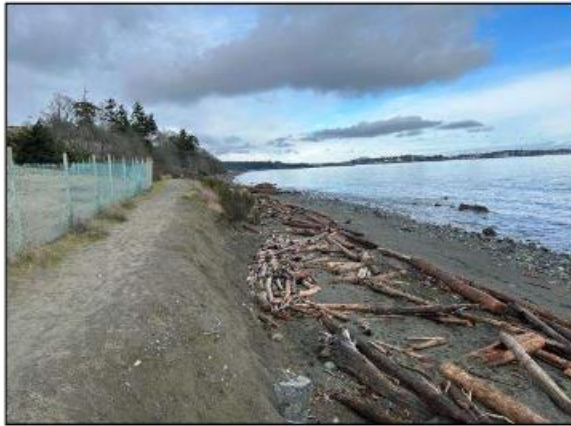
Figure 6 - View of shoreline at location P6

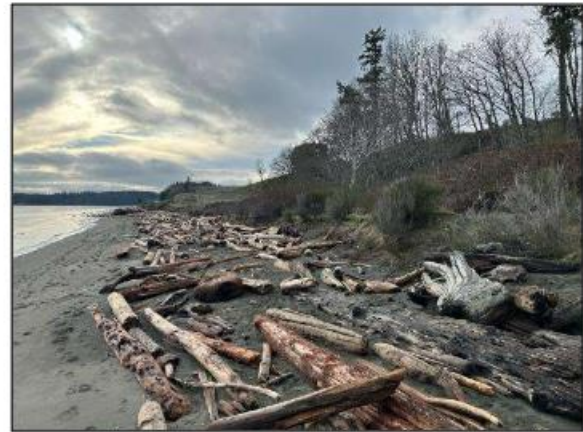
Figure 7 - View of shoreline at location P7

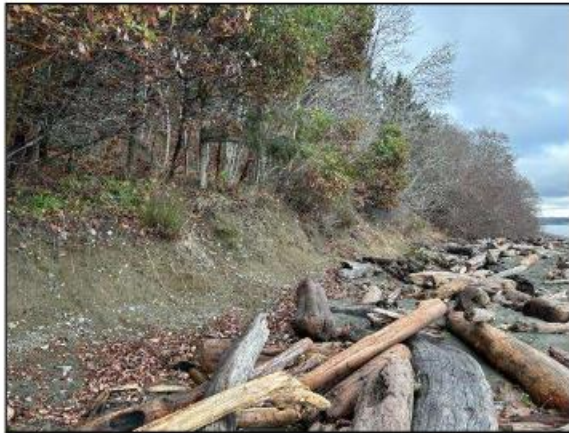
Figure 8 - View of bluff base at location P1

The remainder of the shoreline includes forested or vegetated bluffs along the southern portion (e.g., Figure 8 and Figure 9), exposed portions (e.g., Figure 10), and a lower-sloped portion at the northern end (e.g., Figure 11), such that different mitigative measures may be adopted for different portions. Potential schemes for different portions may range from various harder to softer protection options, generally consistent with the OCP guidelines, that would together assure shoreline resilience, maintain marine habitats, and give attention to sediment retention.

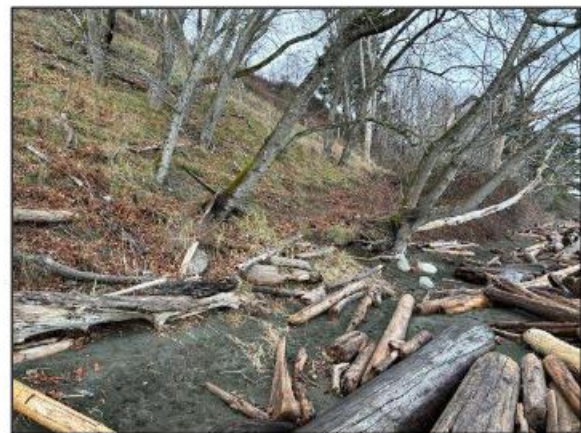
Figure 9 - View of bluff base at location P2

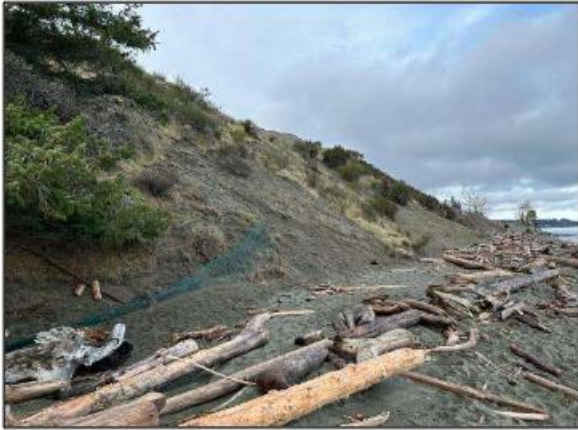
Figure 10 - View of bluff base at location P3

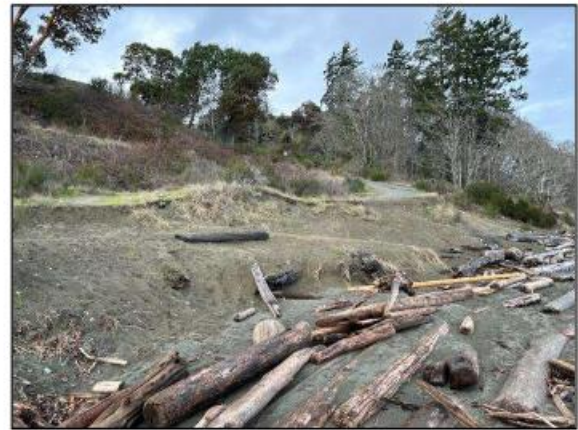
Figure 11 - View of bluff base at location P7

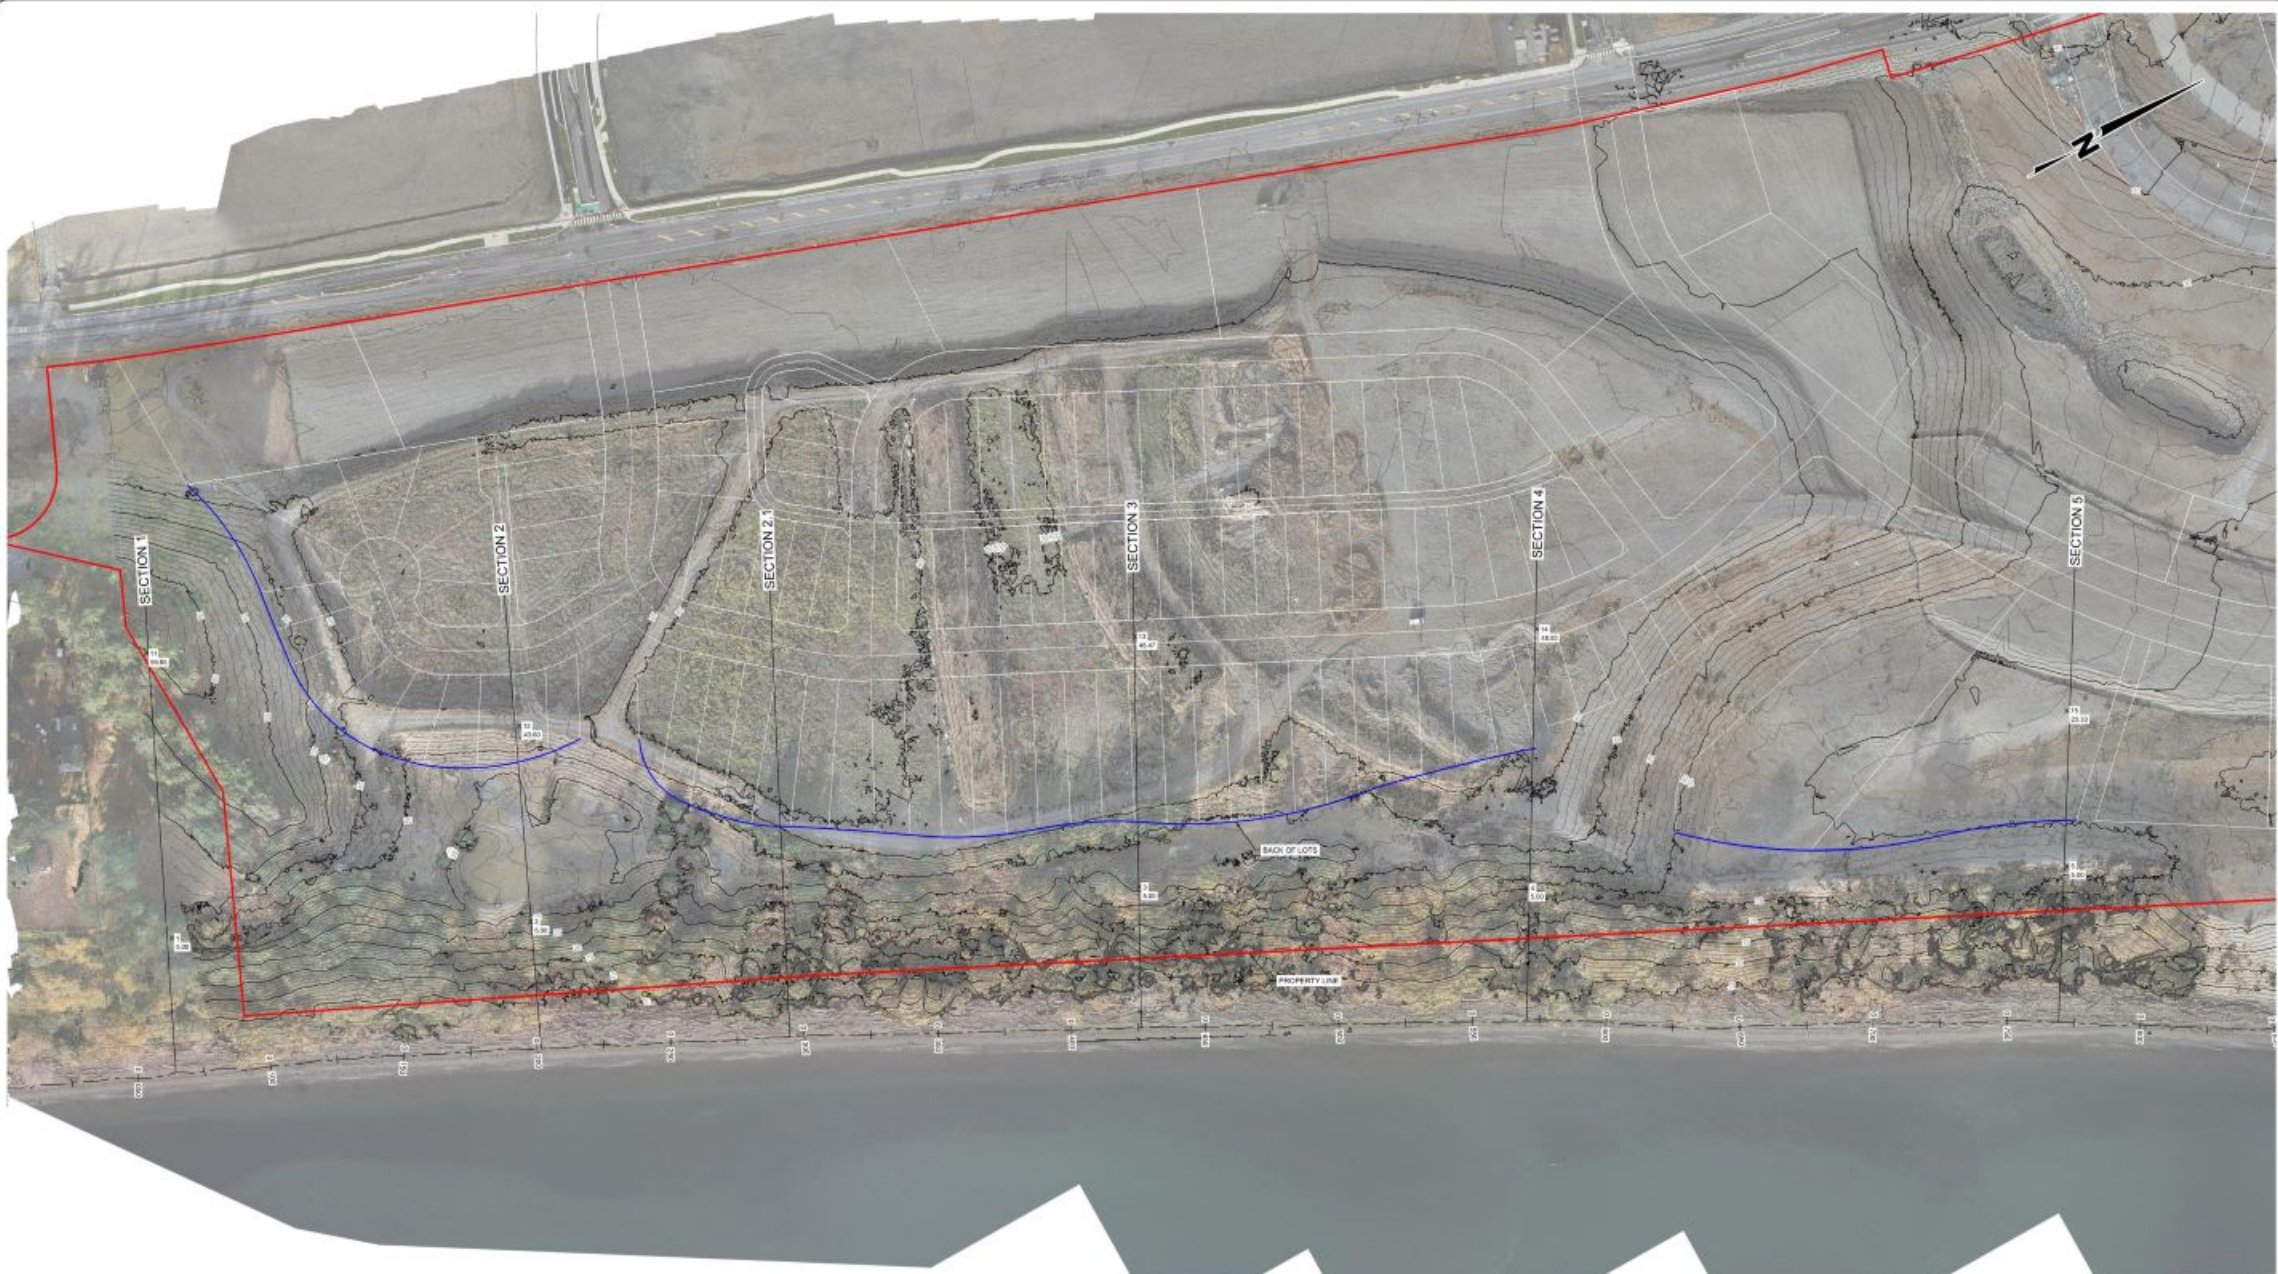
BEACHLANDS - GEOTECHNICAL SECTIONS
 SECTIONS PLAN
 ON POINT PROJECT NO: 174-01
 GEOTECHNICAL ACTIVITY FILE NO: ---
 SHEET 1 OF 2
 ON POINT DRAWING NO: 174-01-SK455

- NOTES:
1. SURFACE SHOWN IS EXISTING GROUND FROM 2022 UAV SURVEY
 2. POINTS SHOWN ARE FROM NORTHWEST HYDRAULIC CORRELATION (NHC) 2018 REPORT "SHEET #16: Royal Beach Park - RD", THEN SCALED TO MATCH GROUND COORDINATES USING SCALE FACTOR 1.000033300.
 3. ALIGNMENT APPROXIMATE HIGH TIDE LINE (FROM 2016 LEAN DATA) AND DOES NOT MATCH NHC ALIGNMENT
 4. AIR PHOTO FROM OCTOBER 2022

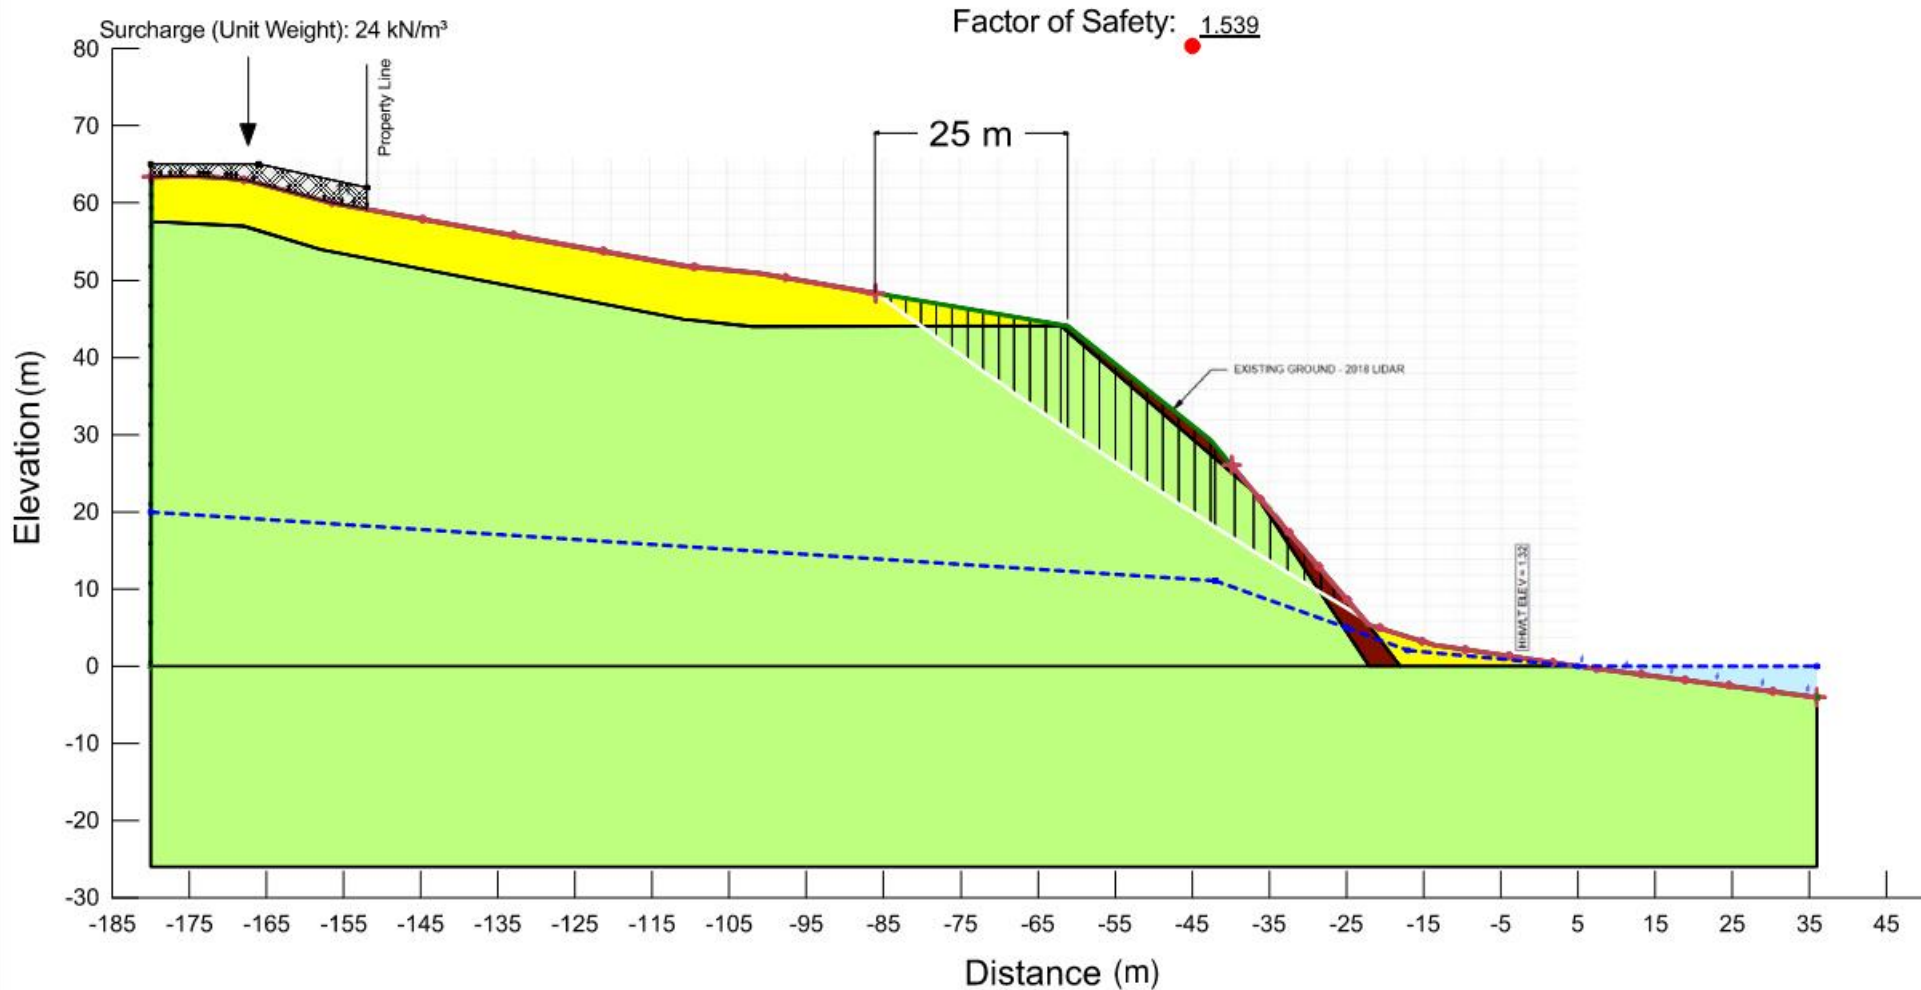
APPENDIX C – SECTION 1 (NO TOE RECESSION)

Color	Name	Unit Weight (kN/m ³)	Effective Cohesion (kPa)	Effective Friction Angle (°)
■	Colluvium	19	0	32
■	Sand	19	0	32
■	Sand and Gravel	20	5	45

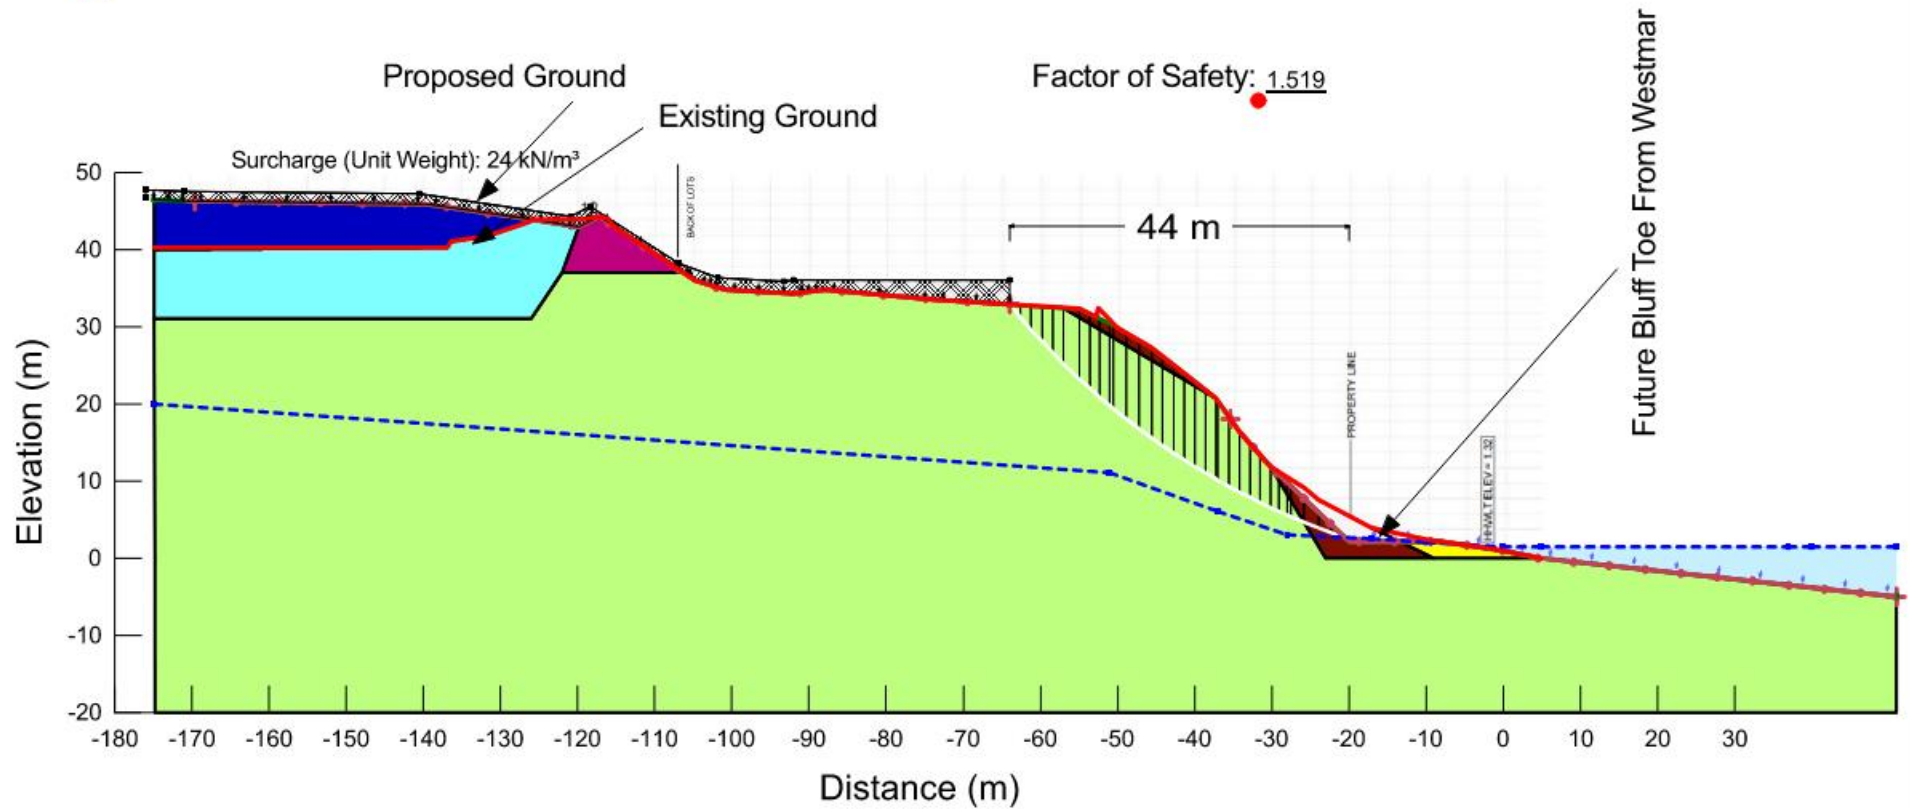
APPENDIX C – SECTION 2 (WITH TOE RECESSION)

Color	Name	Unit Weight (kN/m ³)	Effective Cohesion (kPa)	Effective Friction Angle (°)
■	Colluvium	19	0	32
■	Dike Fill	19	0	32
■	Engineered Fill	19	0	32
■	Pond Sediment	16	0	23
■	Sand	19	0	32
■	Sand and Gravel	20	5	45

Model: Slope Stability Section2 (Static)

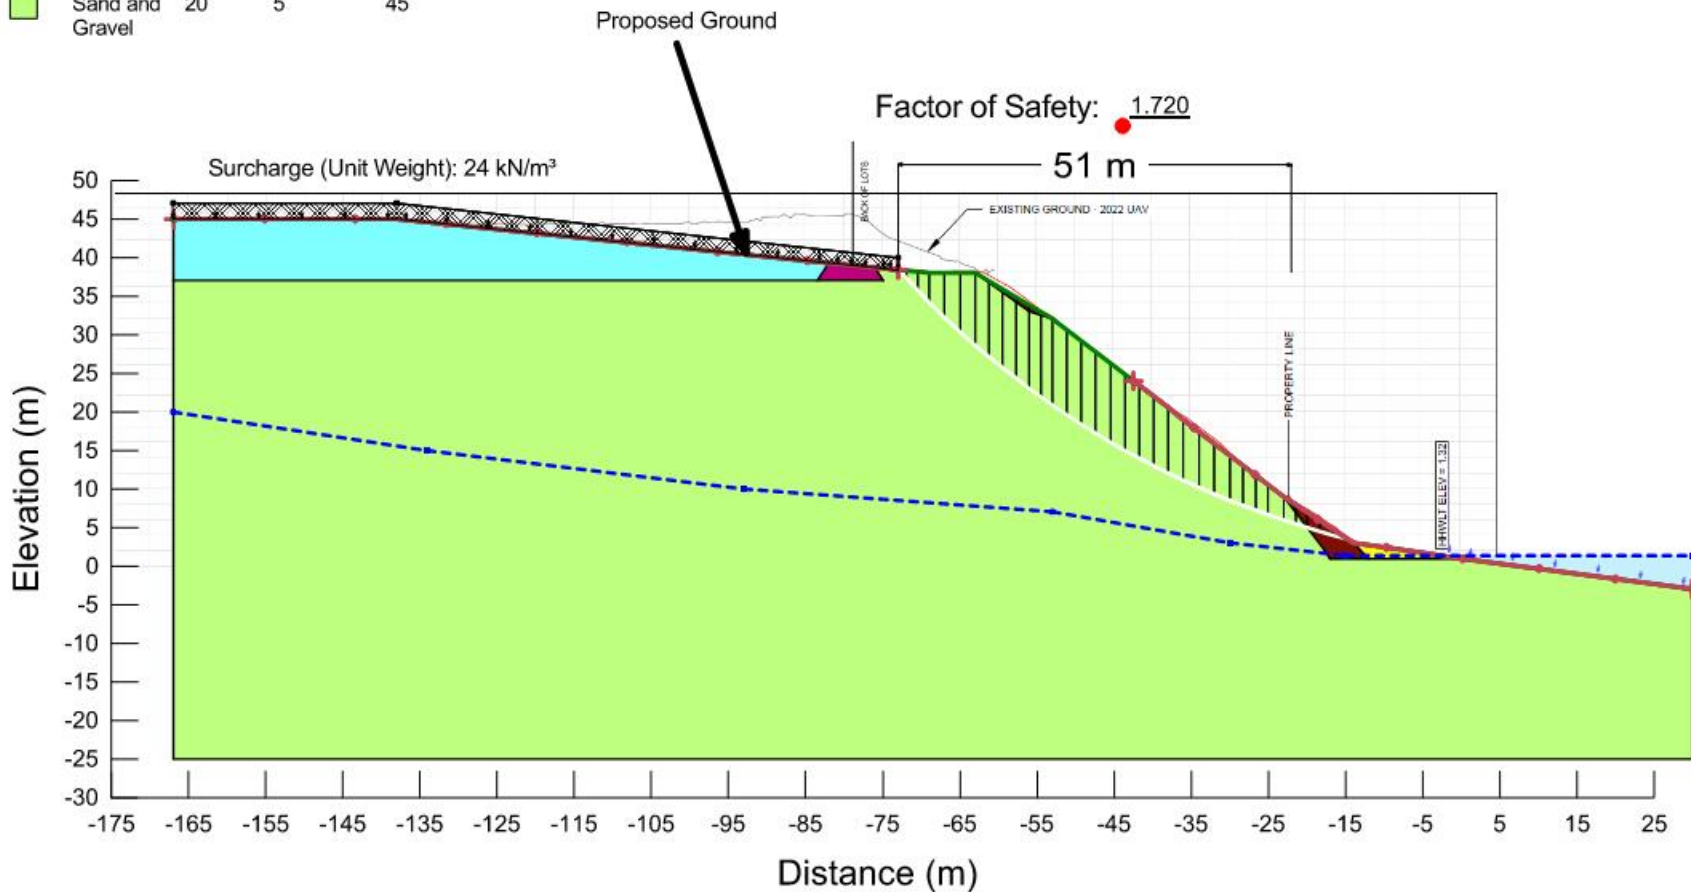
APPENDIX C – SECTION 2.1 (NO TOE RECESSION)

Color	Name	Unit Weight (kN/m ³)	Effective Cohesion (kPa)	Effective Friction Angle (°)
■	Colluvium	19	0	32
■	Dike Fill	19	0	32
■	Pond Sediment	16	0	23
■	Sand	19	0	32
■	Sand and Gravel	20	5	45
