File: DPA00004 - Grading Works at Lot I & Lot J Beachlands

DEVELOPMENT PERMIT AMENDMENT DPA00004

Arborist Report for Development Purposes
Re: Proposed Development, and Construction

**APPENDIX B –
AUGUST 2023 - ON POINT PROJECT ENGINEERS ‘BEACHLANDS –
GEOTECHNICAL SECTIONS’**

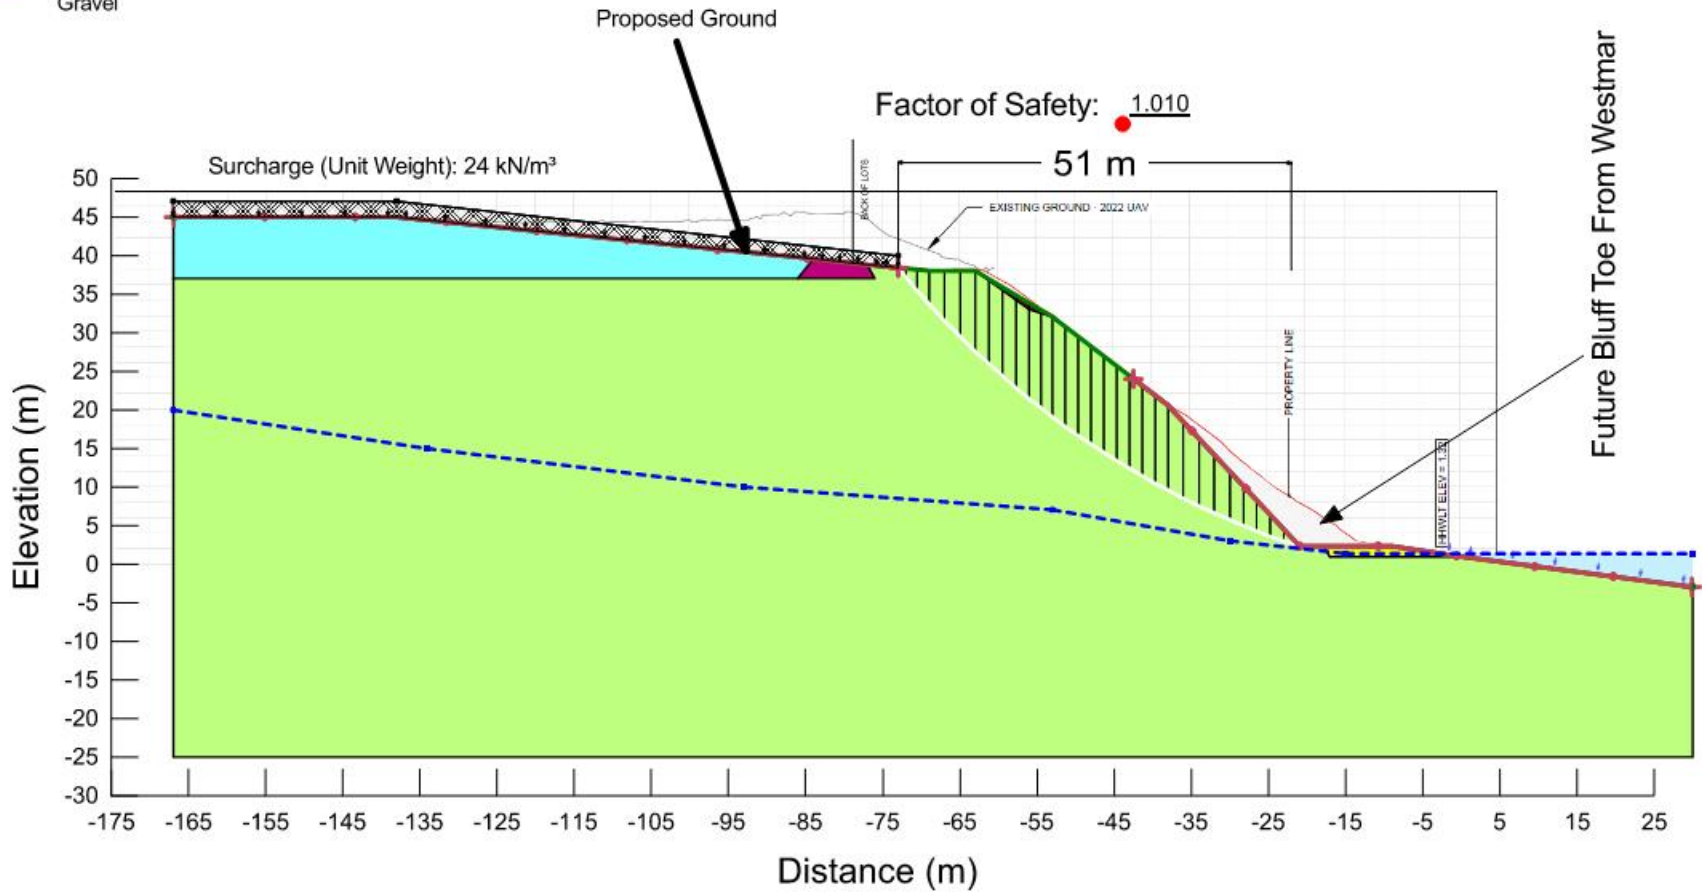
Color	Name	Unit Weight (kN/m ³)	Effective Cohesion (kPa)	Effective Friction Angle (°)
■	Colluvium	19	0	32
■	Dike Fill	19	0	32
■	Pond Sediment	16	0	23
■	Sand	19	0	32
■	Sand and Gravel	20	10	45

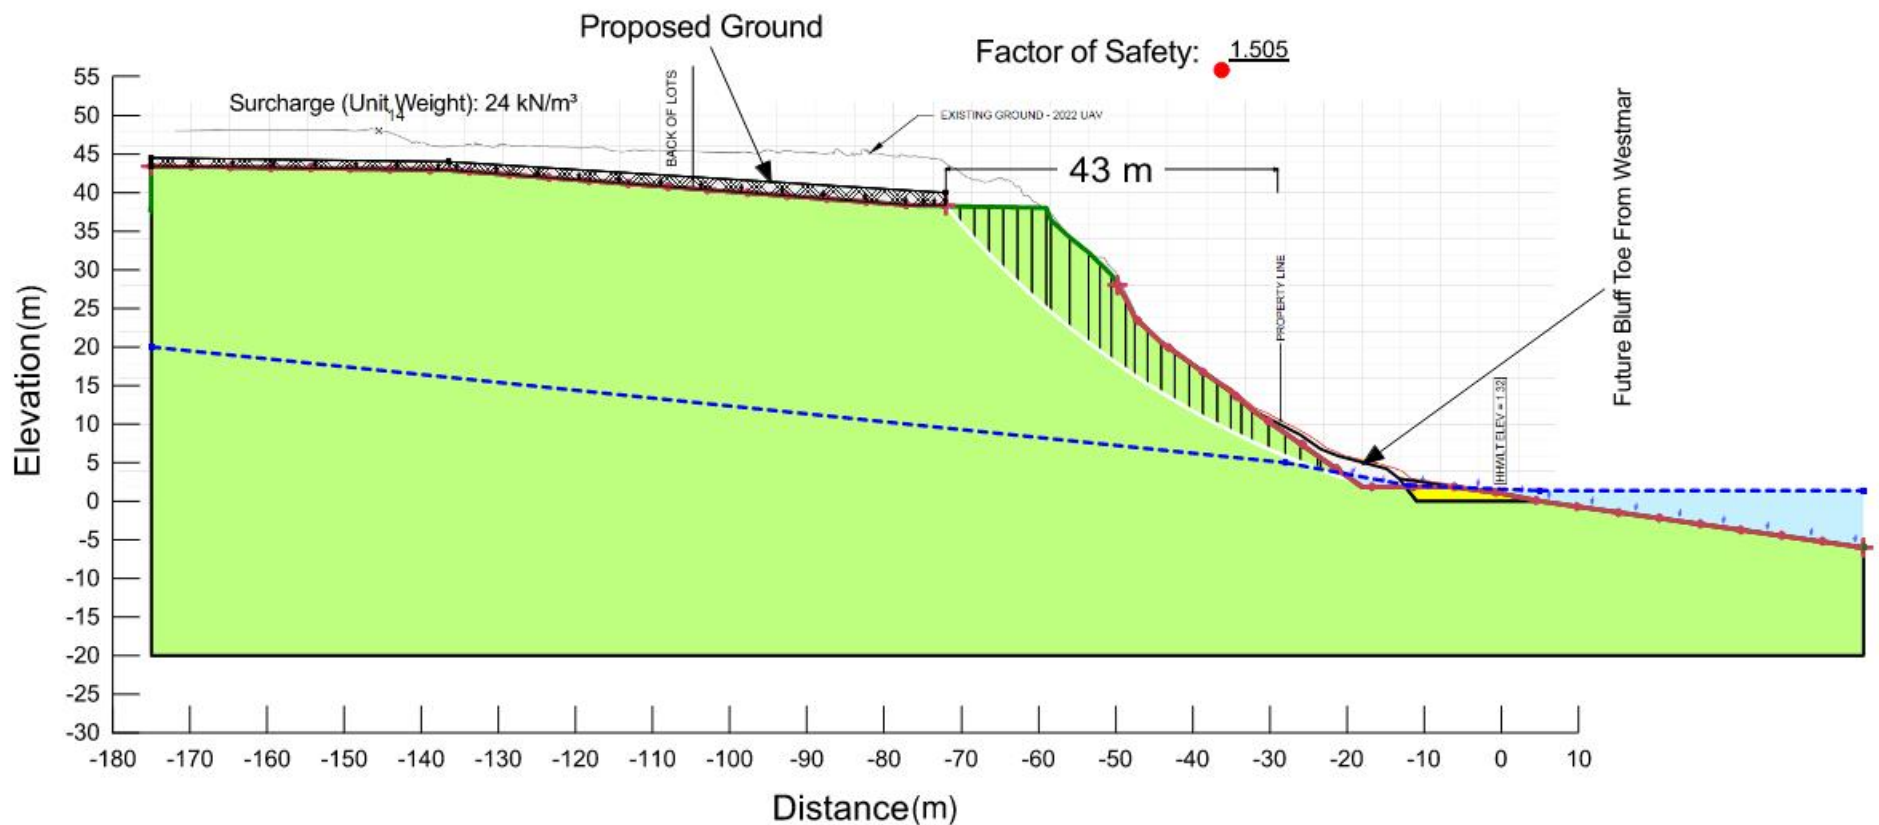
APPENDIX C – SECTION 4 (WITH TOE RECESSION)

Color	Name	Unit Weight (kN/m ³)	Effective Cohesion (kPa)	Effective Friction Angle (°)
Yellow	Sand	19	0	32
Light Green	Sand and Gravel	20	5	45

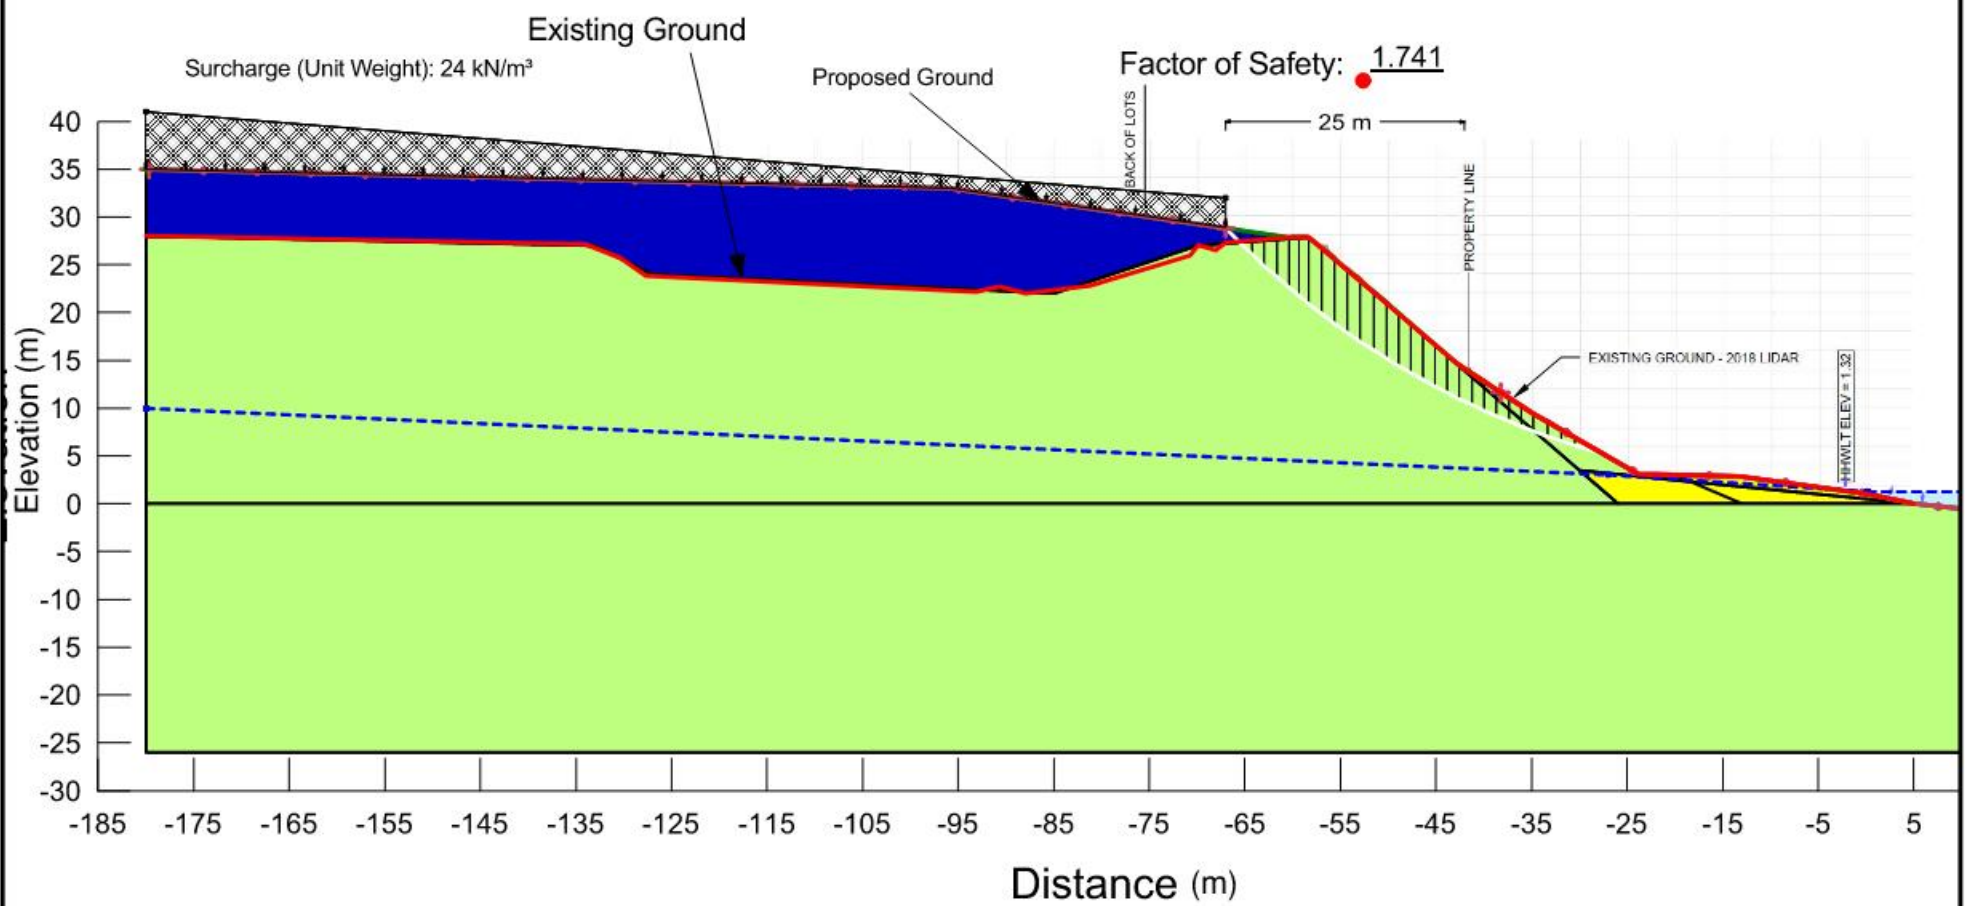
APPENDIX C – SECTION 5 (NO TOE RECESSION)

Color	Name	Unit Weight (kN/m ³)	Effective Cohesion (kPa)	Effective Friction Angle (°)
Blue	Engineered Fill	19	0	35
Yellow	Sand	19	0	32
Light Green	Sand and Gravel	20	5	45

GEOPACIFIC <small>VANCOUVER KARLOOBS CALGARY</small> 1779 W. 75th Avenue Vancouver, B.C. V6P 6P2 P 604.439.0922 F 604.439.9889
Model: Slope Stability Section 5 (Static)		Date: Sept 20, 2023		
Method: Morgenstern-Price		Horz Seismic Coef.: 0		
Site Address : Beachlands Development, Metchosin Road, Colwood, B.C.		Scale : 1:791		
		Analysis by: AAn

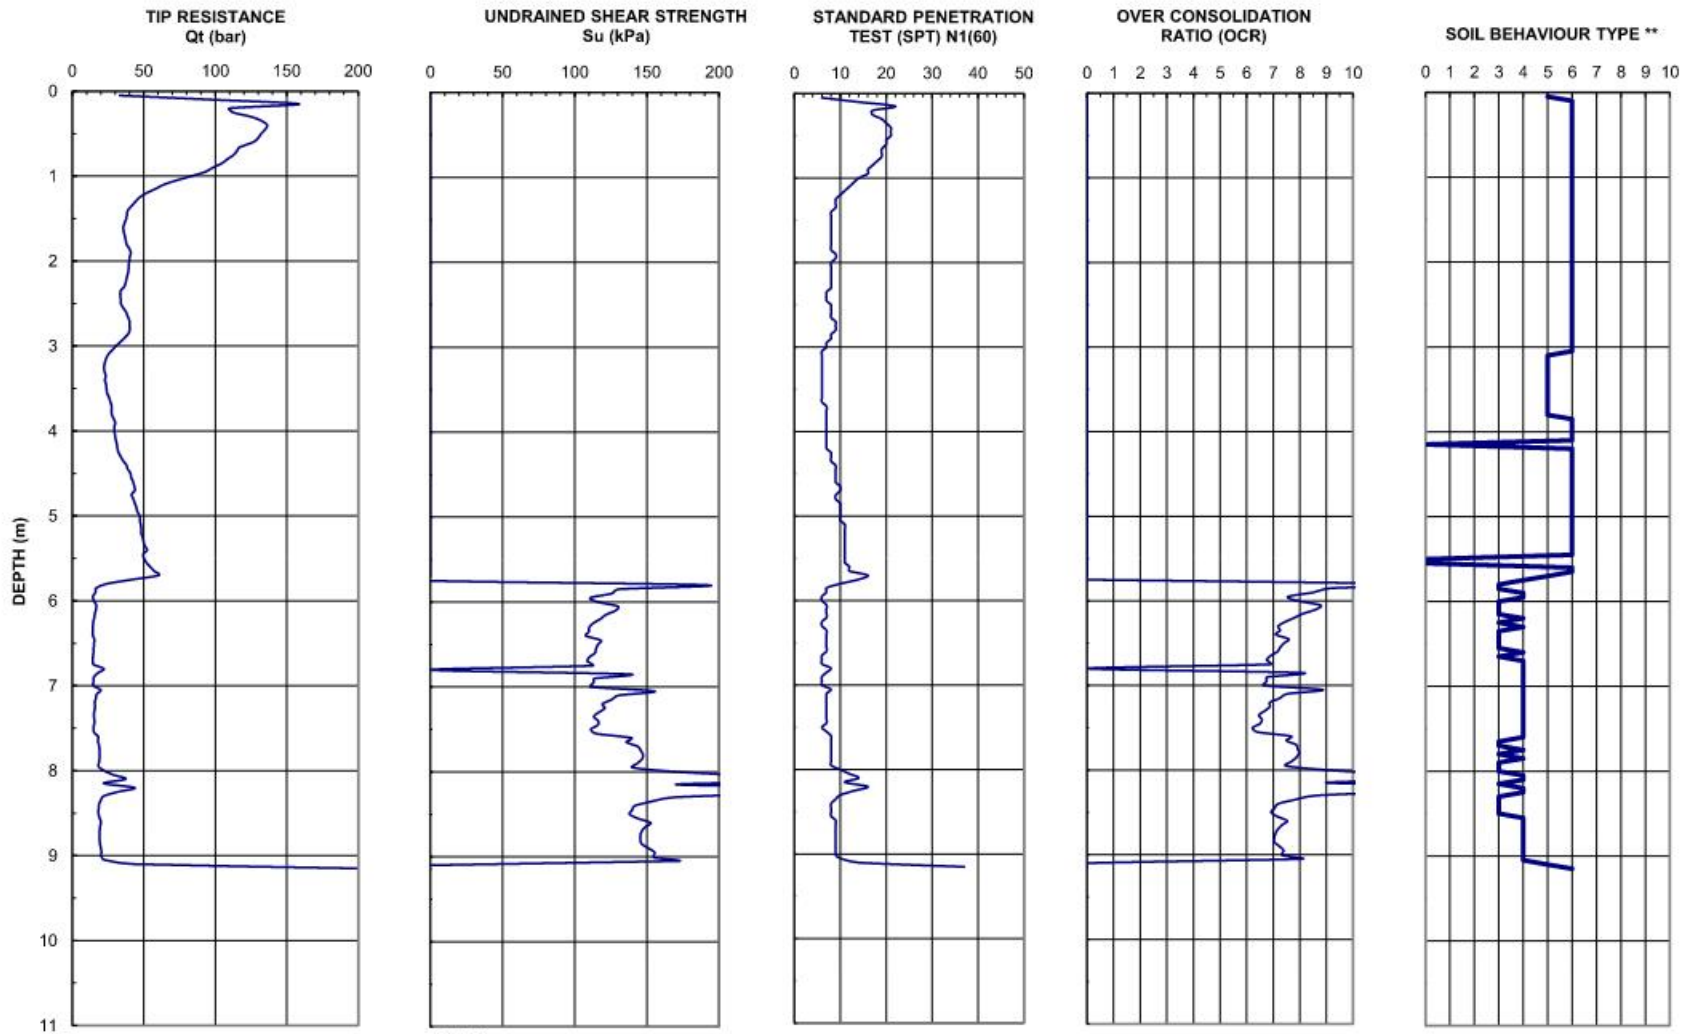
Figure: C.02

Nkt=12

** Based on Robertson et. al 1990

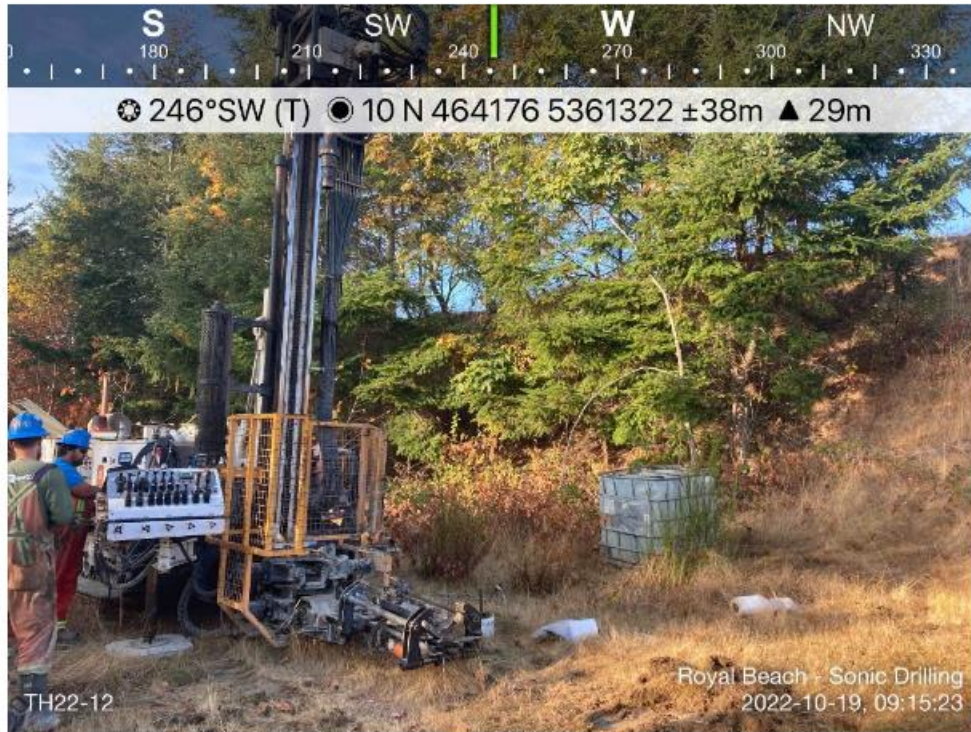
Photo 1. Drillwell advancing sonic drill at TH22-12.

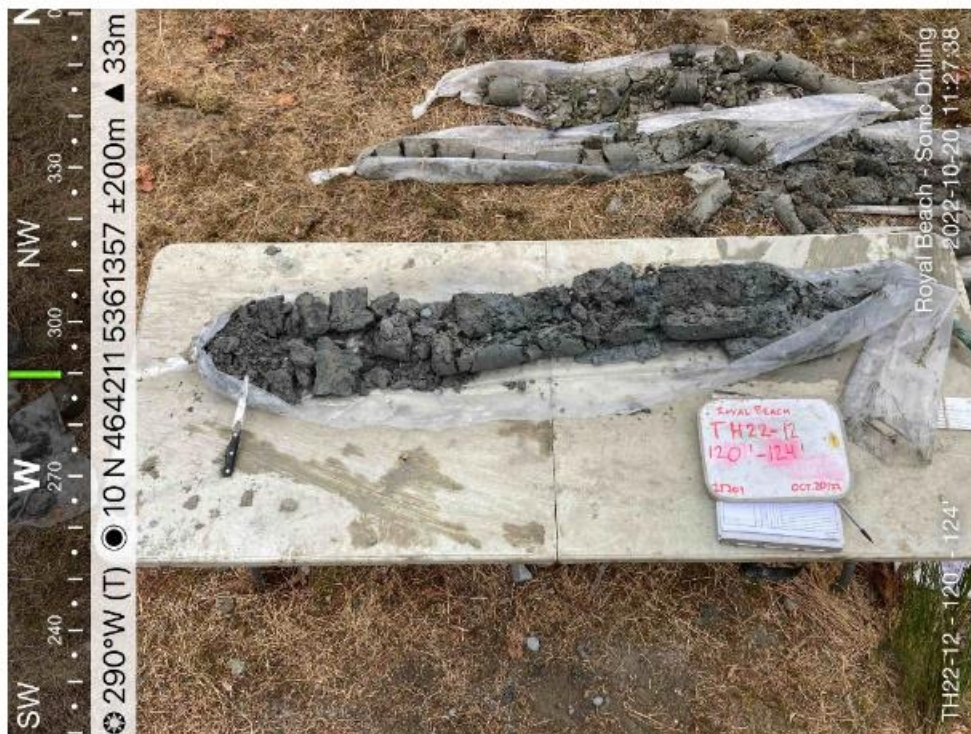
Photo 2. Example of till-like material encountered at TH22-12, depth 36.6 m to 37.8 m bgs.

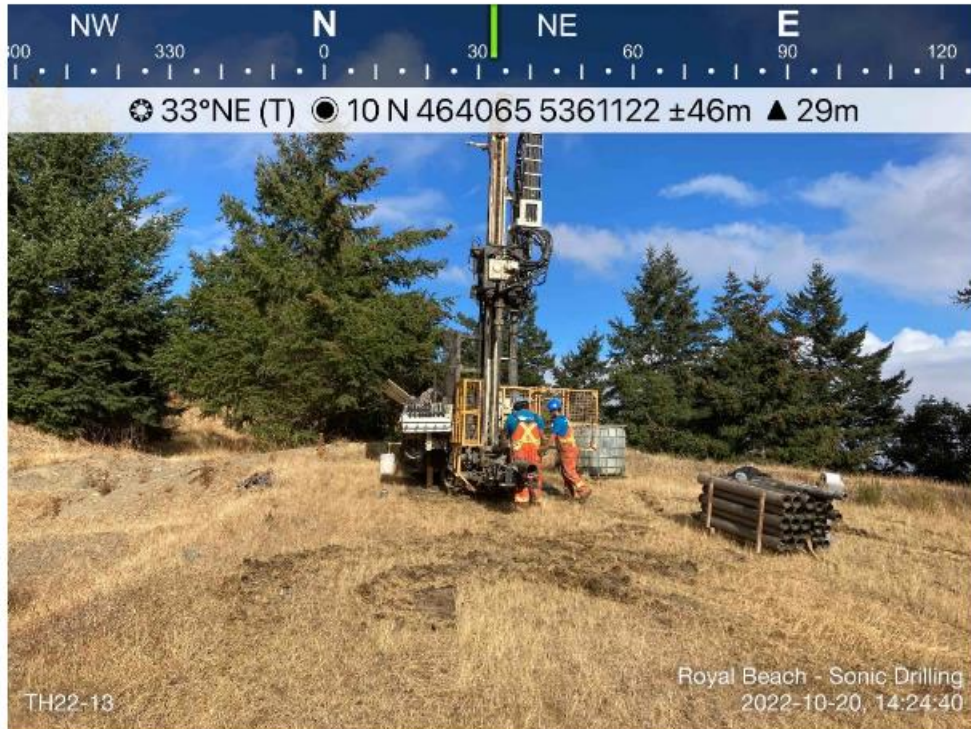
Photo 3. Drillwell advancing sonic drill at TH22-13.

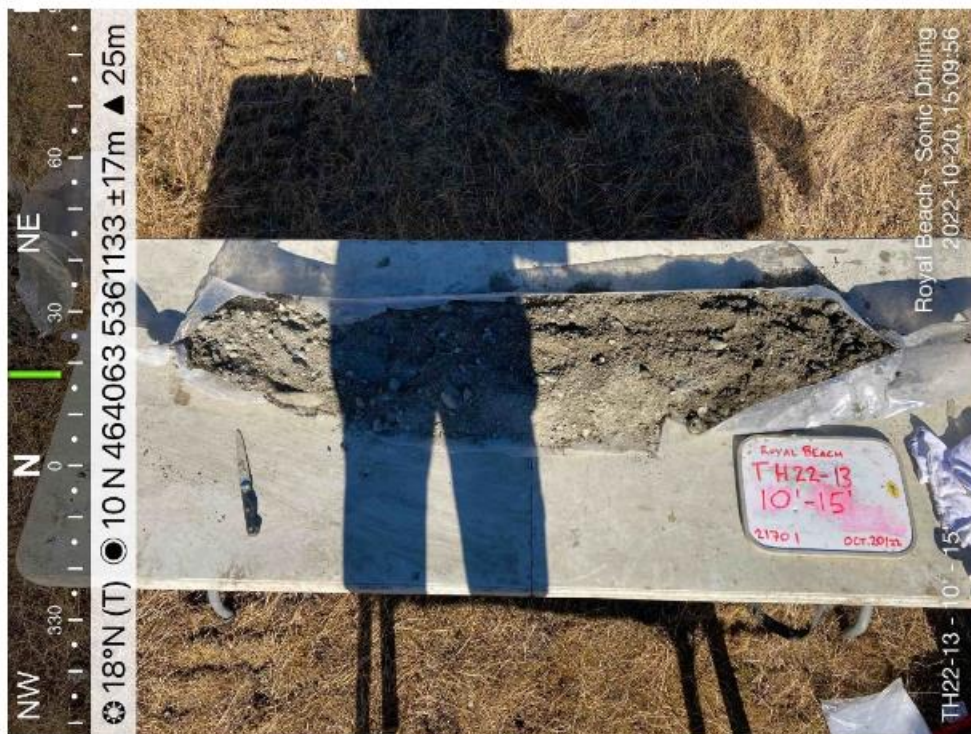
Photo 4. Example of Colwood sands and gravels encountered at TH22-13, depth 3.0 m to 4.6 m bgs.

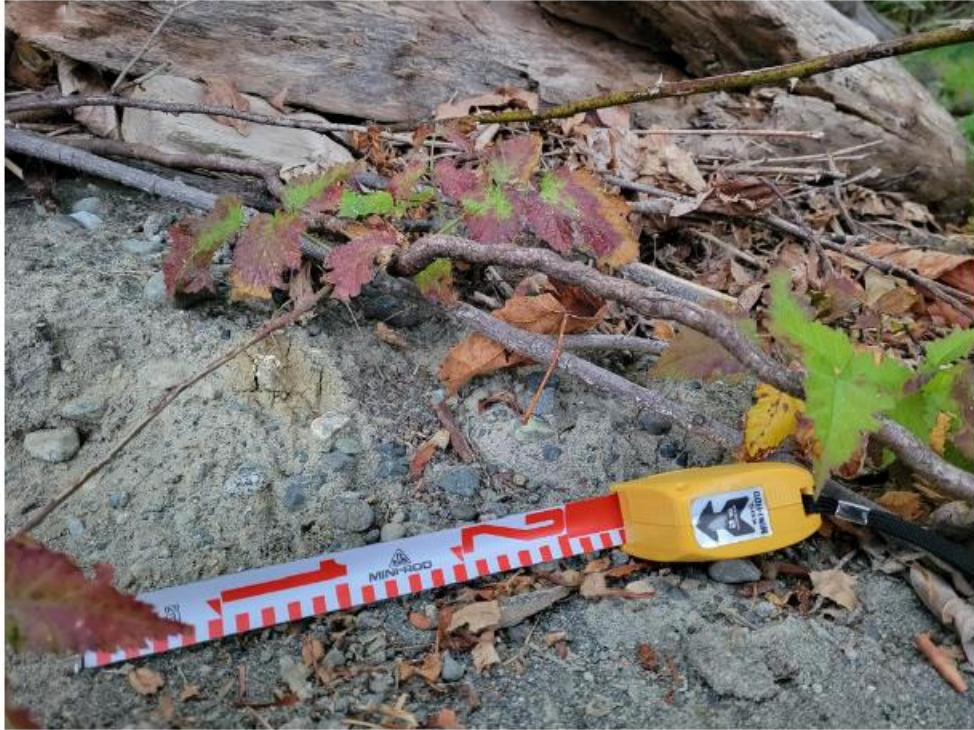
Photo 5. Exposure of cemented, till-like material found along Royal Beach (Wall Sample 1).

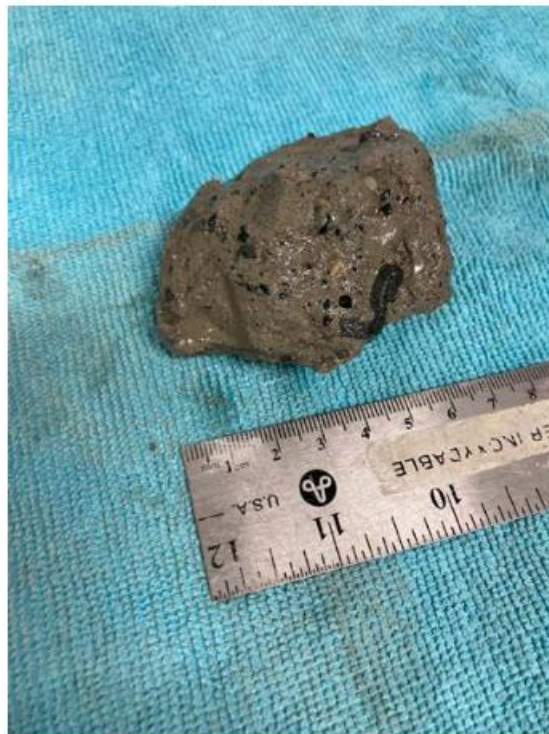
Photo 6. Chunk of intact till-like soil from 16.3 m depth at TH22-13 following soaking.

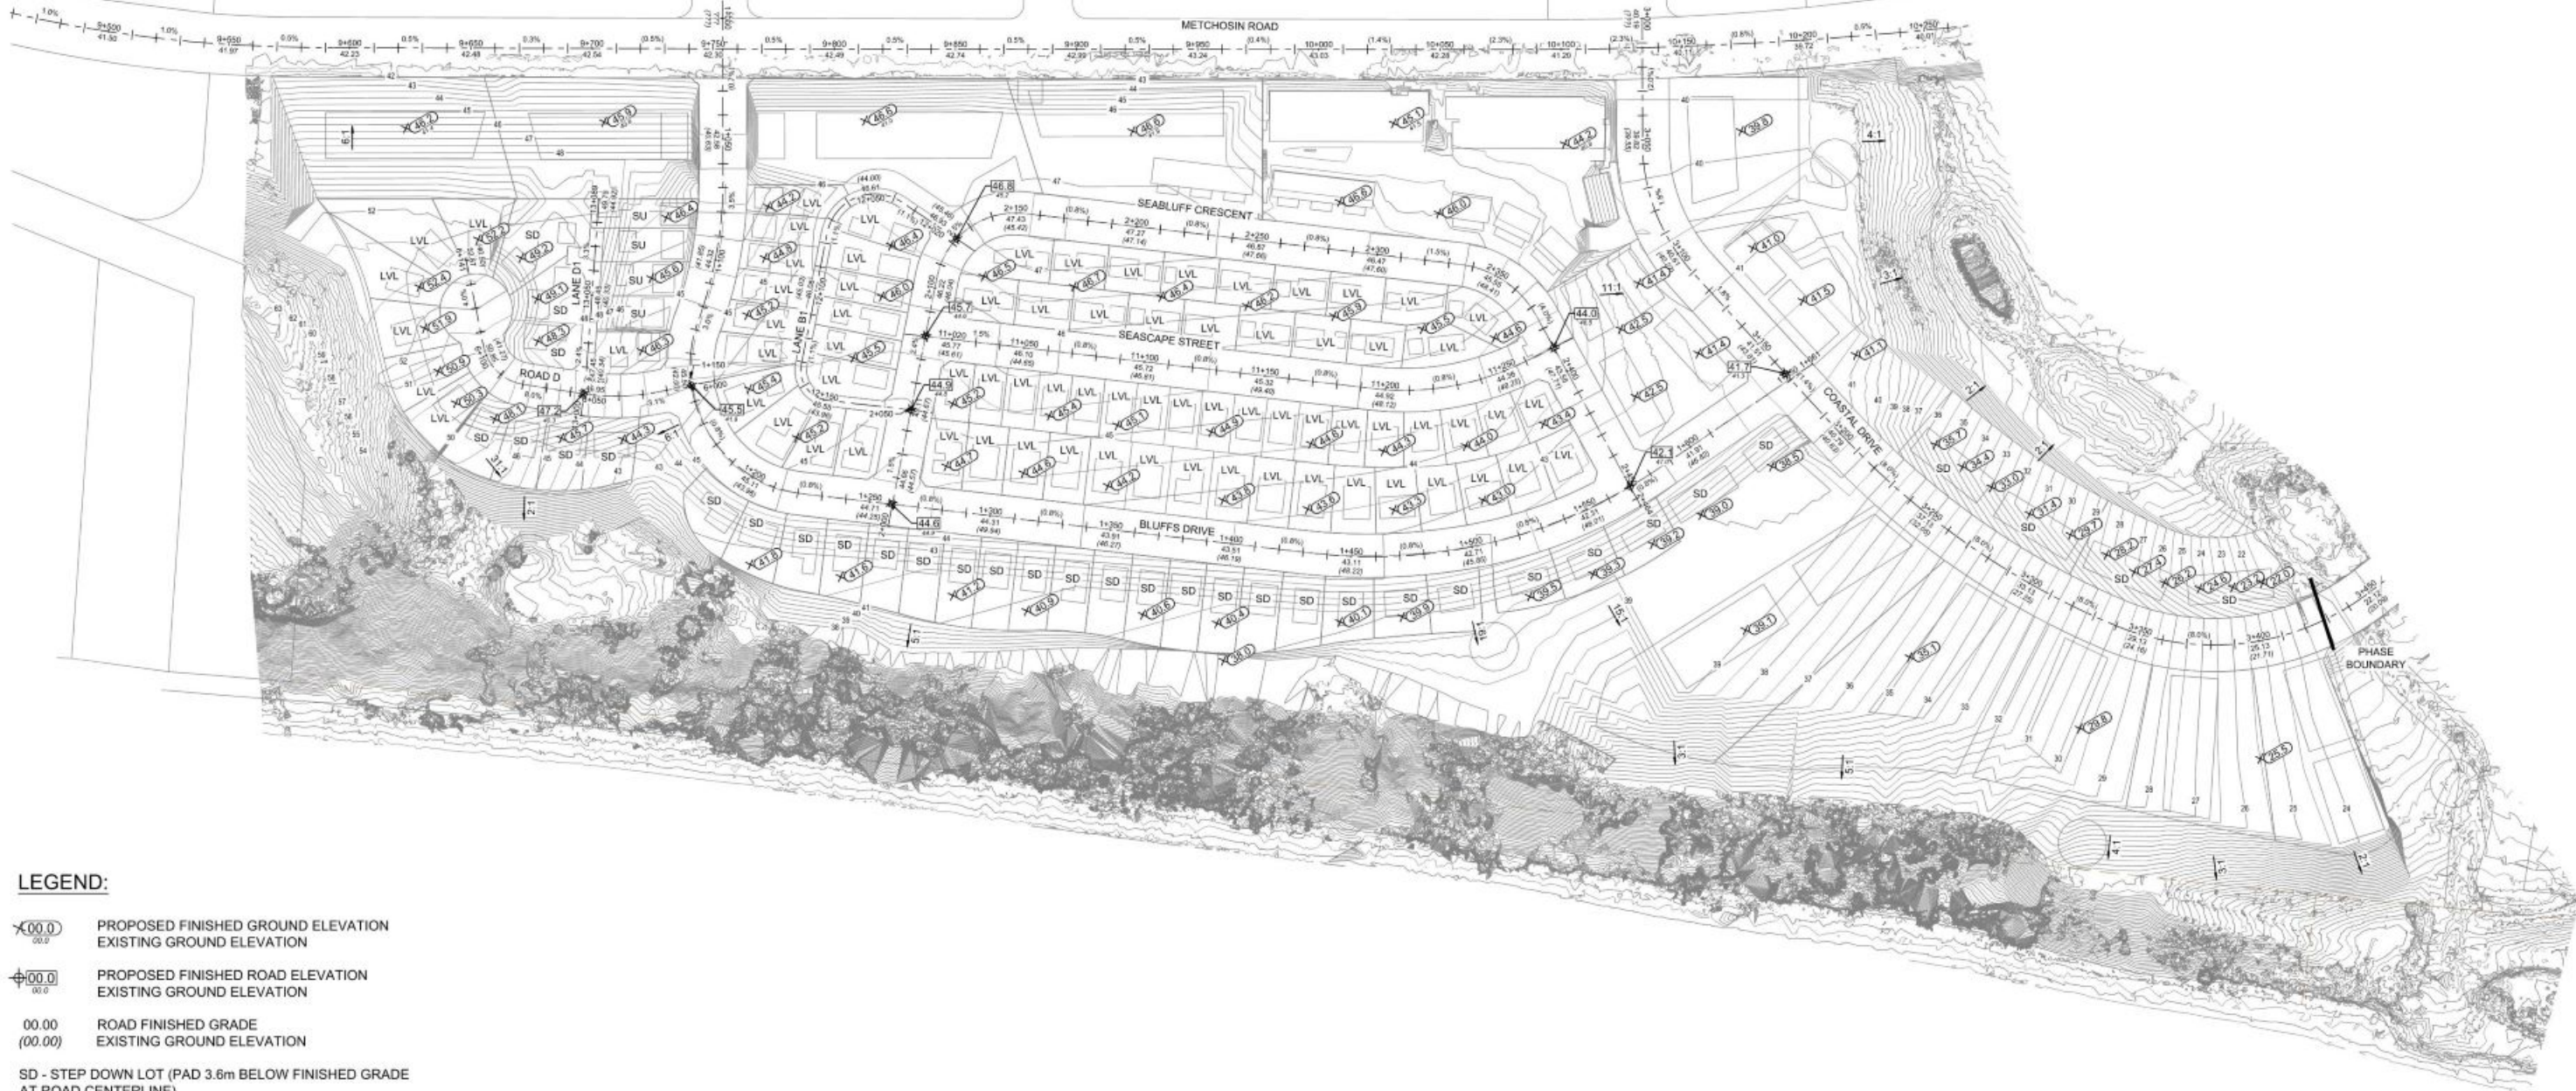
X00.0
00.0 PROPOSED FINISHED GROUND ELEVATION
EXISTING GROUND ELEVATION

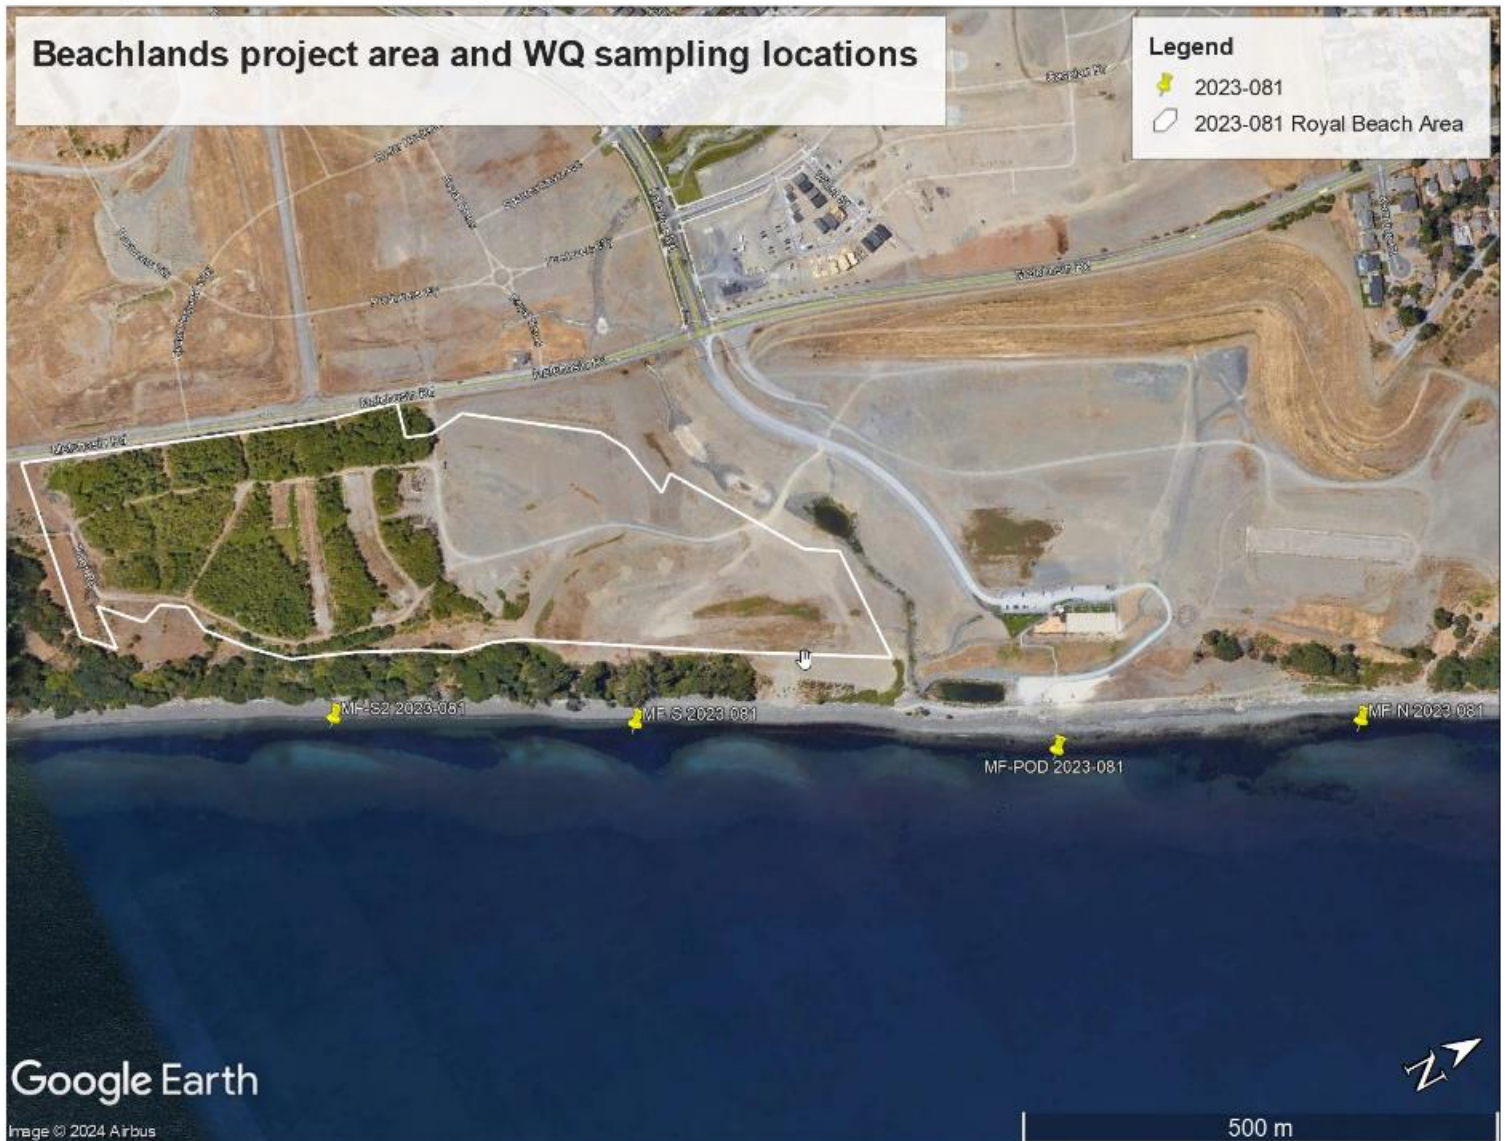
Figure 2. Water Quality Sampling Locations

*Background will be measured at Sample Site MF-S or MF-N depending on which way the longshore current is moving at the time of sampling.

The EM will complete water quality monitoring to provide due diligence reporting with respect to water discharge from site. See Figure 2 for water quality sampling locations.

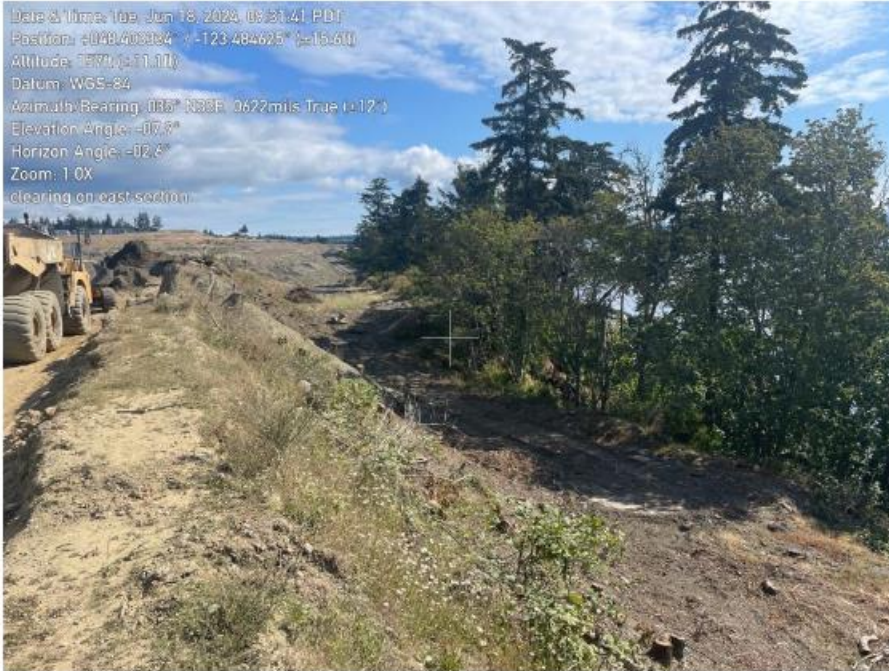
Photo 1. Subcavation to the west of the project perimeter that has resulted in an earthen berm that contains all water to site.

- Excavation to the west of the project perimeter that has resulted in an earthen berm that contains all water to site – Appendix A Photo 1.
- Highly permeable site soils that infiltrate most stormwater event and completely contain the runoff on site.
- An approximately 40 metre wide, steep, vegetated slope that extends from the eastern project limit to the upper high water mark on the beach foreshore. On the upper portion of this slope there is a flat bench ranging from 5 – 10 metres wide – Appendix A Photo 2.

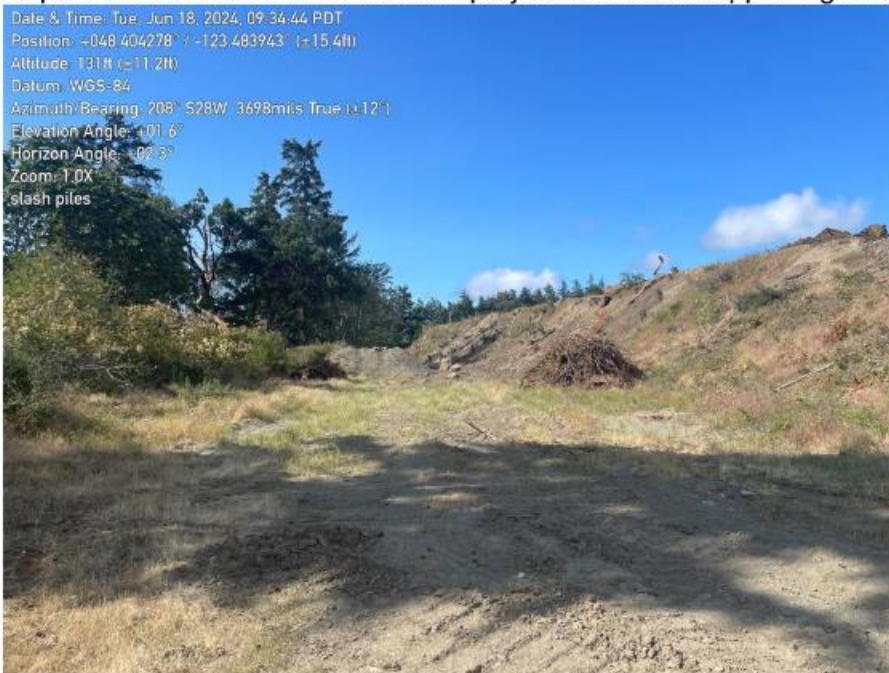
Photo 2. 10 metre wide bench on upper portion of the approximately 40 metre wide, steep, vegetated slope the extends from the eastern project limit to the upper high water mark on the beach foreshore.

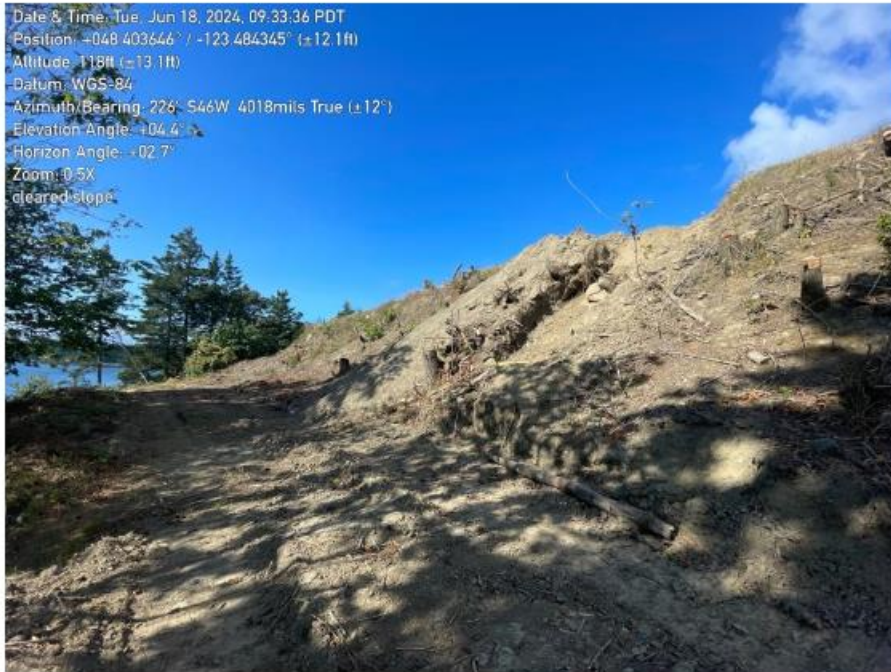
Photo 3. Trees have been previously cleared from the grading area.

- Removal of existing vegetation and organic material within the grading area. Trees have been previously cleared – Appendix A Photo 3.
- Installation of tree protection fencing at the eastern edge of the project area to prevent damage from grading activities to trees on the uppermost edge of the vegetated slope.
- Subexcavation of existing site and grading to final design; grading will create Lots 5 – 26 and Site 15. This involves removing the existing earthen berm and grading site so the stormwater will flow east and north – refer to grading and drainage drawing in Appendix B.
- From the east edge of the of the level residential building lots 5 – 26 and Site 15, grading will result in a 4H:1V east aspect slope that connects to an 800 metre long north draining swale designed to discharge to the existing sediment detention pond at the Royal Bay backshore.

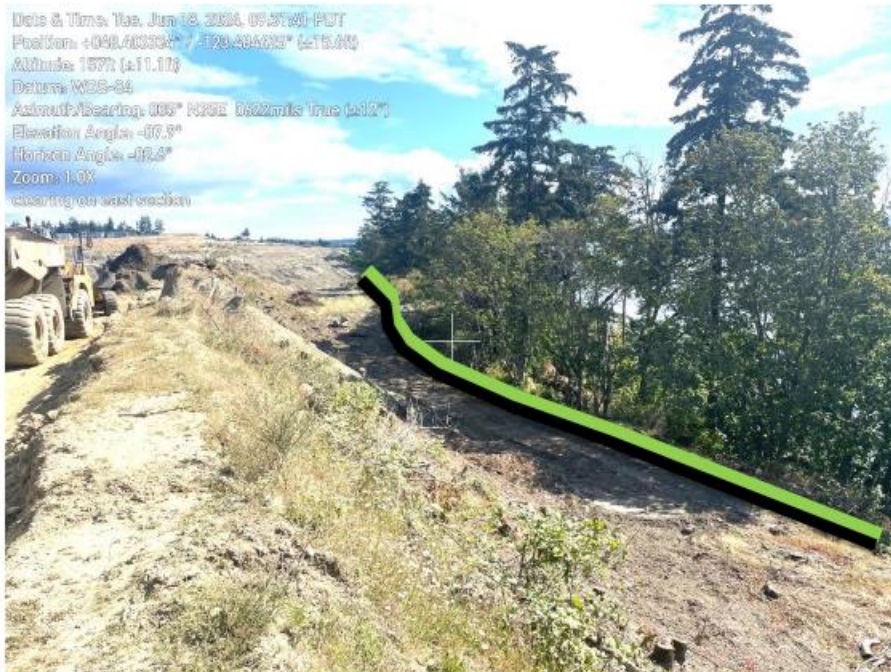
Photo 4. Silt fence (black) is to be installed inside the base of the tree protection fencing (green) as an additional protective measure against the migration of turbid stormwater offsite to the marine foreshore. Silt fencing installation can wait until mid-September.

Trees to be retained are to be protected during construction by the installation of snow fencing. If grading works are not completed by Sept 15, silt fence is to be installed at the base of the fencing as an additional protective measure against the migration of turbid stormwater offsite to the marine foreshore – Appendix A Photo 4. The timing and need for this additional mitigation measure will be determined by Corvidae in consultation with Turnbull.
